Rehabilitation Alternatives for Structures Used on the Flocculation, Sedimentation and Filtration Processes at the Ponce De Leon Water Treatment Plant in Mayagüez, Puerto Rico

Orlando Vargas Del Valle

Master of Engineering in Civil Engineering

Polytechnic University of Puerto Rico

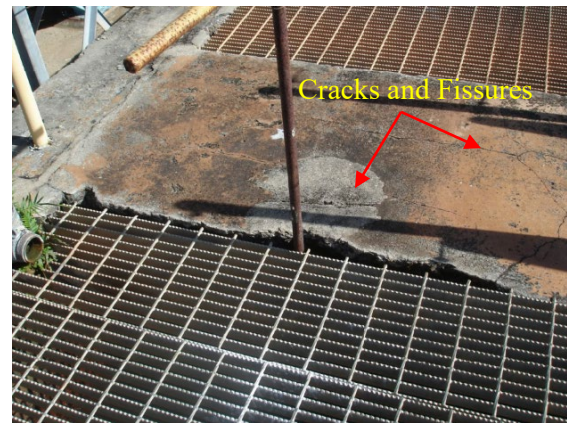
- Concrete floor cracks and spalling were present on the elevated concrete slabs and wall edges of the flocculation channel. Figures 8 and 9 show those conditions on the flocculation channel.
- General corrosion due to coating delamination and contaminant accumulation on metallic elements such as: valves, appurtenances, pipes, and structural steel handrails.
- Valves and mechanical components, including supports, show pitting and general corrosion. Coating delamination and flaking were observed during inspection.

Figure 8
Concrete Cracks on Elevated Concrete Slab

Based on results, the recommended alternative for cracks repair is the routing and sealing method with polyurethane sealant and for concrete spalling is the partial depth repair. The structural evaluation concluded that cracks and spalling on concrete structures at the Ponce de Leon WTP could be

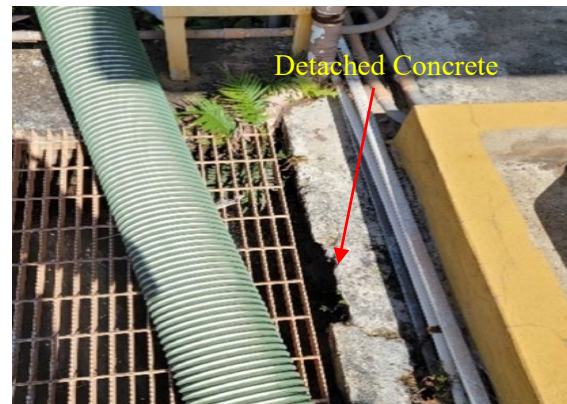
Figure 9
Concrete Detachment on Channel Wall Edge

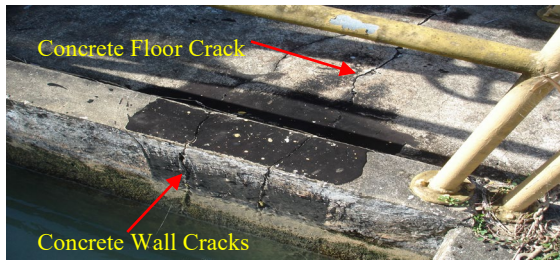
- Concrete walls on sedimentation basins show cracks and fissures. Concrete spalling and detachment were found on several areas. Evidence of tar used to seal cracks was observed. Figure 10 presents the condition of a sedimentation basin concrete wall on the Ponce de Leon WTP.
- General and crevice corrosion were observed on metallic elements such as: valves, appurtenances, pipes, structural steel handrails, bolts and pipeline supports due to coating failure and contaminant accumulation.
- Spot corrosion and pitting was observed on handrails base plates and bolts due to coating failure and delamination.
- Vertical ladder at sedimentation tank #3 showed evidence of general corrosion and complete material loss. Figure 11 shows the actual condition of vertical ladder at tank #3.

Concrete Floor and Wall Cracks on Sedimentation Basin

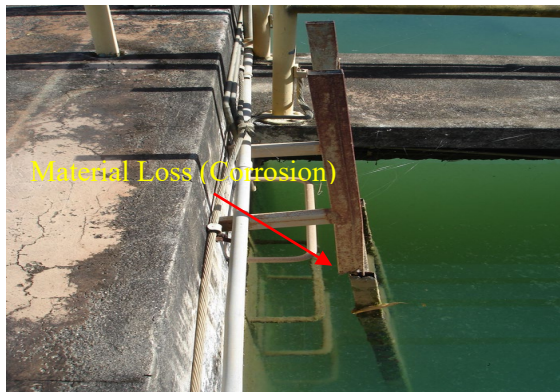
Figure 11

Material Loss Due to Corrosion on Tank #3 Vertical Ladder

Related to corrosion treatment on metallic elements, the analysis concluded that the best and most cost-efficient alternative was the use of epoxy and polyurethane high-performance coatings. Protective coatings can extend the useful life of metallic structures and mechanical components because they chemically adhere to the metallic substrate and create a barrier against corrosion. For this reason, a good surface preparation is of utmost importance before applying the coatings.

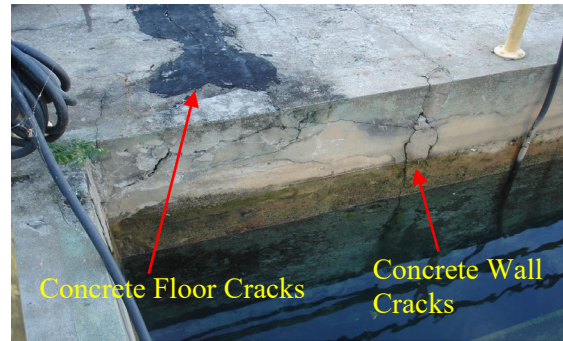
- Concrete walls on old filters basins show cracks and fissures. Concrete spalling and detachment were found on several areas. Evidence of tar used to seal cracks was observed. Figure 12 presents the concrete surface condition of filter #4 on the Ponce de Leon WTP.
- Spot corrosion and pitting was observed on handrails due to coating delamination. Missing bolts were observed on handrails base plates.

Old Filter Basin Concrete Wall Cracks
