Reconstruction Award of a Single-Family Housing Unit Affected By Hurricanes Irma and María

*Paola María Rivera
Master in Engineering Management
Dr. Hector J. Cruzado
Graduate School
Polytechnic University of Puerto Rico*

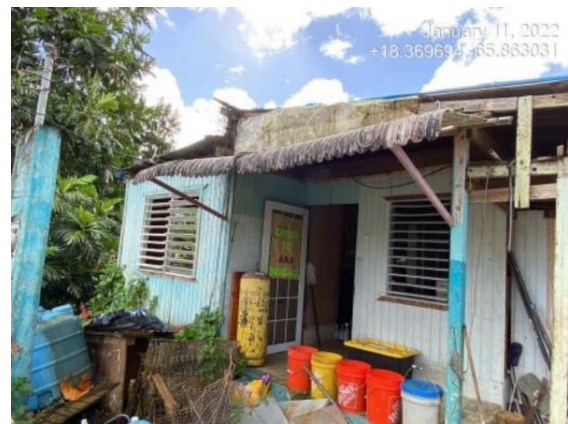
Figure 1
View of front elevation of the assessed property

The property was deemed a total loss, with storm damage up to an extent not feasible to repair, with an estimated cost of repair that surpassed the

minimum program cap of \$60,000. As the site was not located at floodway or floodplain and no significant extraordinary site conditions were identified, a reconstruction award for a single story, 2-bedroom model home type was proposed and accepted by the applicant. Construction progress inspections were performed, until case closure was completed.

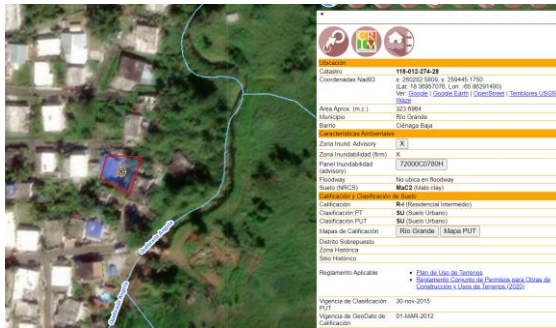
Figure 2

The site was located at an area of minimum flood hazard, zone X, as per FIRM map, and located off the ABFE map. A natural stream named “Quebrada Angela” was identified at an approximate distance of 60 meters from site, as shown in Figure 2. According to the Puerto Rico Risks and Hazards dashboard, the site could potentially encounter risks of flood (100 years), hurricane winds, earthquake, liquefaction, and landslide, as shown in Figure 3.

Location of property site, as per Puerto Rico Planning Board site

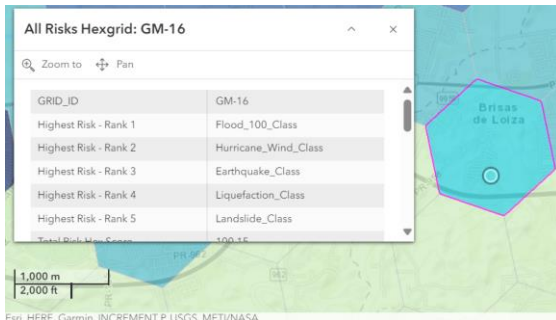
Figure 3

Potential risks at site, as per the Puerto Rico Risks and Hazards Dashboard hexgrid GM-16

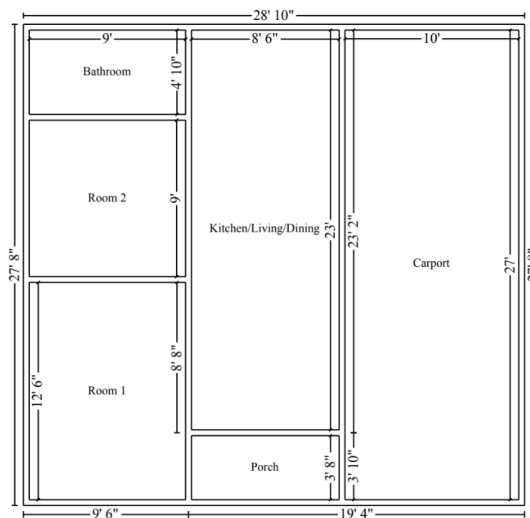
Storm damage identified at the property was documented and a detailed cost estimate was developed in Xactimate format, with an Applicant Final Lien amount of \$150,054.34 at closeout. A sketch of the property was developed in Xactimate, as seen in Figure 4.

Figure 4
Sketch of assessed property, including actual measurements
and descriptions of rooms

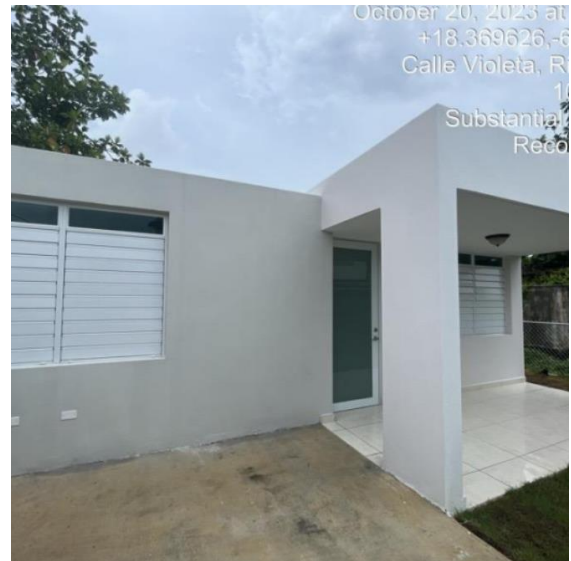
Figure 5
One-story 2-bedroom model home unit constructed at the original assessed site

Site walk and construction progress inspections were performed, including foundation, walls, structure, substantial and final milestone inspections, with total construction time of 261 days. A total task order cost of \$392,940.44, distributed in demolition costs of \$20,458.52, environmental tests and abatement costs of \$9,482.46, soft costs for storm damage location of \$38,832.95, hard costs of \$159,452.72, and cap exception costs of \$184,612.19, was submitted by the construction manager and approved by the grant manager, resulting in an Applicant Final Lien amount of \$150,054.34 at closeout.
