Abstract

The Johnson & Johnson Vision plant in Añasco manufactures Non-Toric intraocular lenses (IOLs), which have recently experienced a recurring issue of unintended fiducial markings. These defects, if undetected, compromise product integrity, patient safety, and production efficiency. Root cause analysis determined human errors specifically incorrect machine programming selection as the primary contributor. To address this, an upgraded version of CNC Program Assembler software was developed to enforce correct program usage through barcode scanning, preventing operational oversights. Complementary procedural actions included operator training, standard operating procedure updates, and engineering test validations. A cost benefit analysis revealed substantial material and labor losses due to incorrect production, justifying the proposed corrective measures. The revised system enhances traceability, reduces waste, and ensures consistent quality. Ongoing monitoring and feedback collection are planned to ensure sustainable improvements and compliance. This initiative reflects a strategic integration of risk management, process optimization, and quality assurance to support continuo

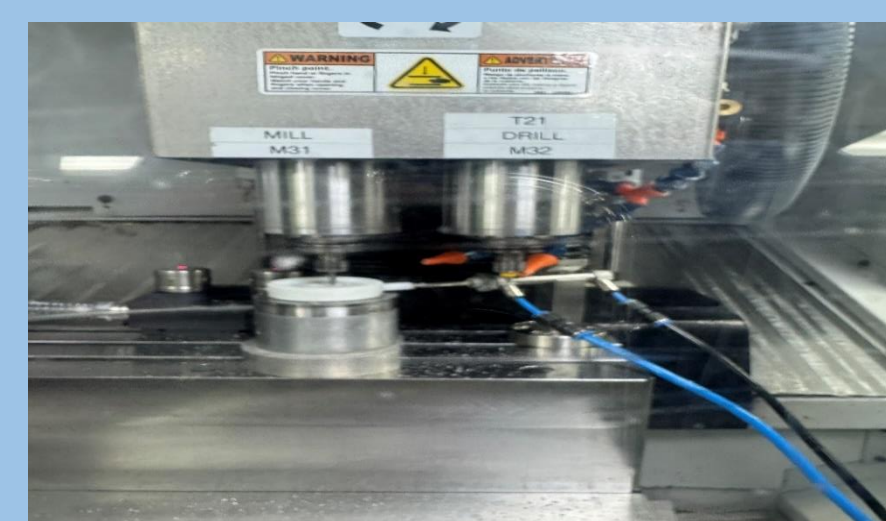
Figure 2: Milling Machine

Operator interviews and SOP reviews revealed inconsistencies in program selection. Operators occasionally failed to switch from Program 091 to Program 051 when transitioning from Toric to Non-Toric orders, causing the machine to execute the last loaded program and apply unintended fiducial markings to Non-Toric lenses.

Root cause analysis confirmed that the defect stemmed from human error rather than equipment malfunction or software bugs. The failure to switch programs was attributed to oversight and lack of an automated verification system. Although post-milling inspections typically caught the defects, the resulting scrap and time loss were substantial.

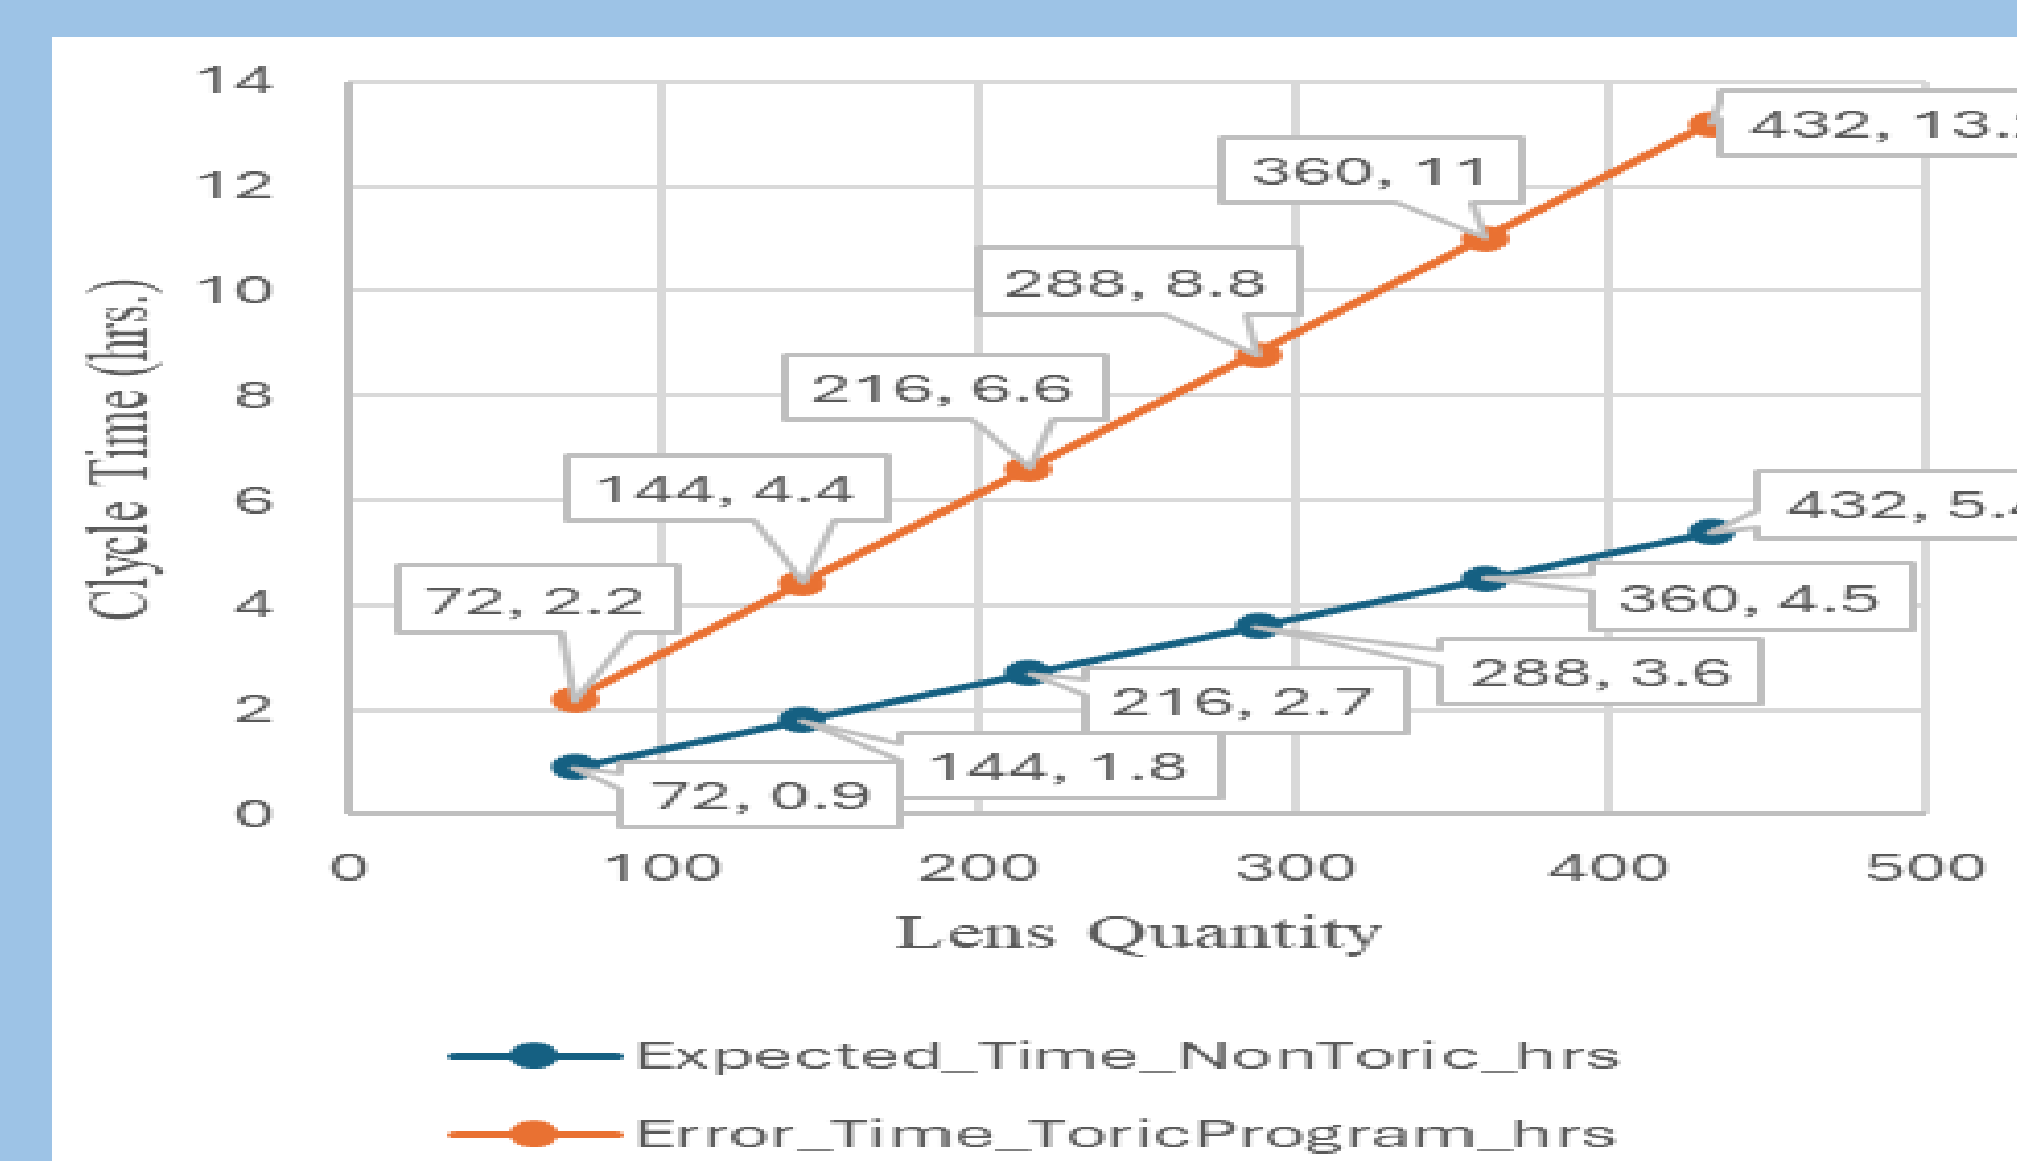
Figure 5: Time comparison of correct vs incorrect production order execution

The results of this research confirmed that unintended fiducial markings on Non-Toric intraocular lenses were primarily caused by operator error during the selection of CNC milling programs. Statistical trend analysis and time studies demonstrated the substantial impact of these errors on manufacturing efficiency and resource utilization. Under correct production conditions, the average cycle time for Non-Toric lenses was 45 seconds. However, when an erroneous program was used, cycle times increased by a factor of 2.44, and entire batches were rendered defective. Table 1 illustrated that for a batch of 432 units, this translated to 7.8 hours of additional production time and full material scrapping.
