Paola María Rivera Rivera / Advisor: Dr. Héctor Cruzado
Polytechnic University of Puerto Rico

Hurricanes Irma and María caused significant damage in 2017 to single-family housing units located at the east coast of the island of Puerto Rico. Eligible homeowners of storm damaged units could apply for the Community Development Block Grant, Repair, Reconstruction and Relocation program (CDBG-R3). An initial assessment to identify storm damage was performed to a single-family housing unit located at the municipality of Río Grande. Storm damages and environmental factors were identified, documented, and analyzed using Xactimate software. Lead Based Paint (LBP) and Asbestos Containing Material (ACM) surveys were performed, finding lead-based paint at ceramic tiles in Bathroom and asbestos in vinyl flooring tiles at the Porch, Bedroom 1 and Bedroom 2 areas. A detailed cost estimate was developed, surpassing the minimum program cap of \$60,000, and an initial project intent of reconstruction was proposed, as the property was storm damaged to an extent not feasible to repair. Site walk inspection was performed, an initial scope was submitted by the Construction Manager, and the applicant ac

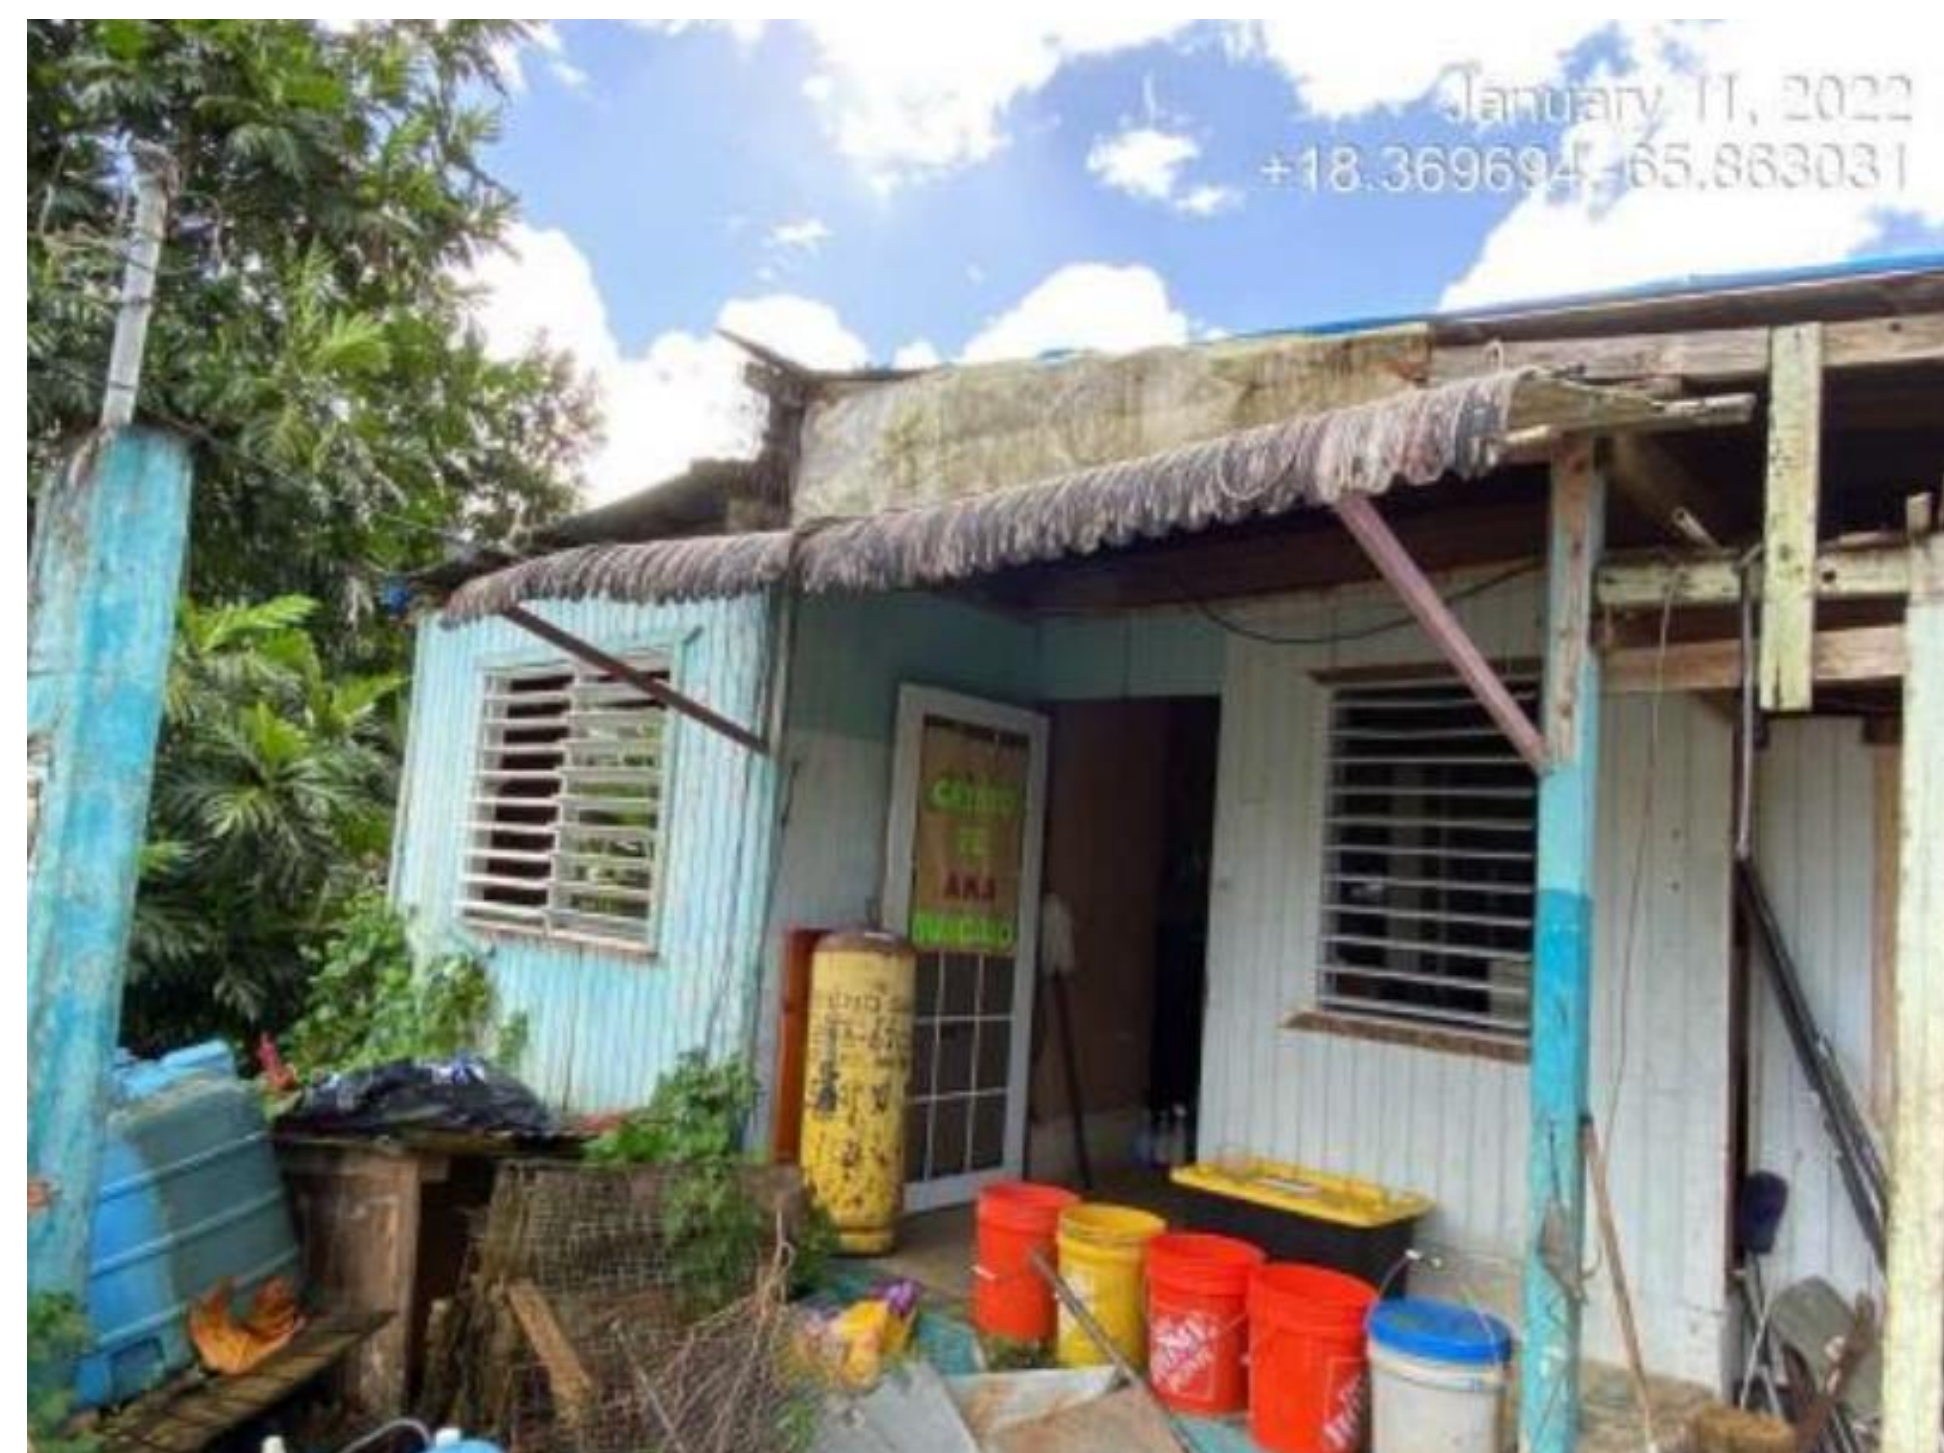
Figure 1. View of front elevation of the assessed property

Storm damages at the property surpassed the minimum program cap for repairs of \$60,000, as the property was built in wood walls and metal roofing system in wood framing elements. As the property was damaged to such an extent that it was not feasible to repair, it was declared a total loss. Moreover, as the site was located at a zone of minimum flood hazard, zone X, as per FIRM and ABFE maps, and no extraordinary site conditions were identified, a reconstruction award was proposed and accepted by the applicant. As presented in Figures 5 and 6, a one-story two-bedroom model home was built in 261 days, with a total task order cost of \$392,940.44 and an Applicant's Final Lien Amount of \$150,054.34 at closeout.

Storm damage at the property surpassed the minimum program cap for repairs of \$60,000. As the property was located at a zone of minimum flood hazard, zone X, as per FIRM and ABFE maps, and no extraordinary site conditions were identified, a reconstruction award was proposed and accepted by the applicant, for a one-story 2-bedroom model home. A Lead-Based Paint survey was performed by a certified environmental inspector, and wall and floor ceramic substrates resulted positive in Lead-based paint contains, as shown in Table 1, with results of 1.8 and 3.8 mg/cm². An Asbestos - Containing Material survey at the assessed property was also performed, and vinyl tile samples were found to have 2% and 3% asbestos, as shown in Table 2. Site walk and construction progress inspections were performed, including foundation, walls, structure, substantial and final milestone inspections, with total construction time of 261 days. A total task order cost of \$392,940.44, distributed in demolition costs of \$20,458.52, environmental tests and abatement costs of \$9,482.46, soft costs for storm damage location of \$38,832.95, hard costs of \$159,452.72, and cap exception costs of \$184,612.19, was submitted by the construction manager and approved by the grant manager, resulting in an Applicant Final Lien amount of \$150,054.34 at closeout.

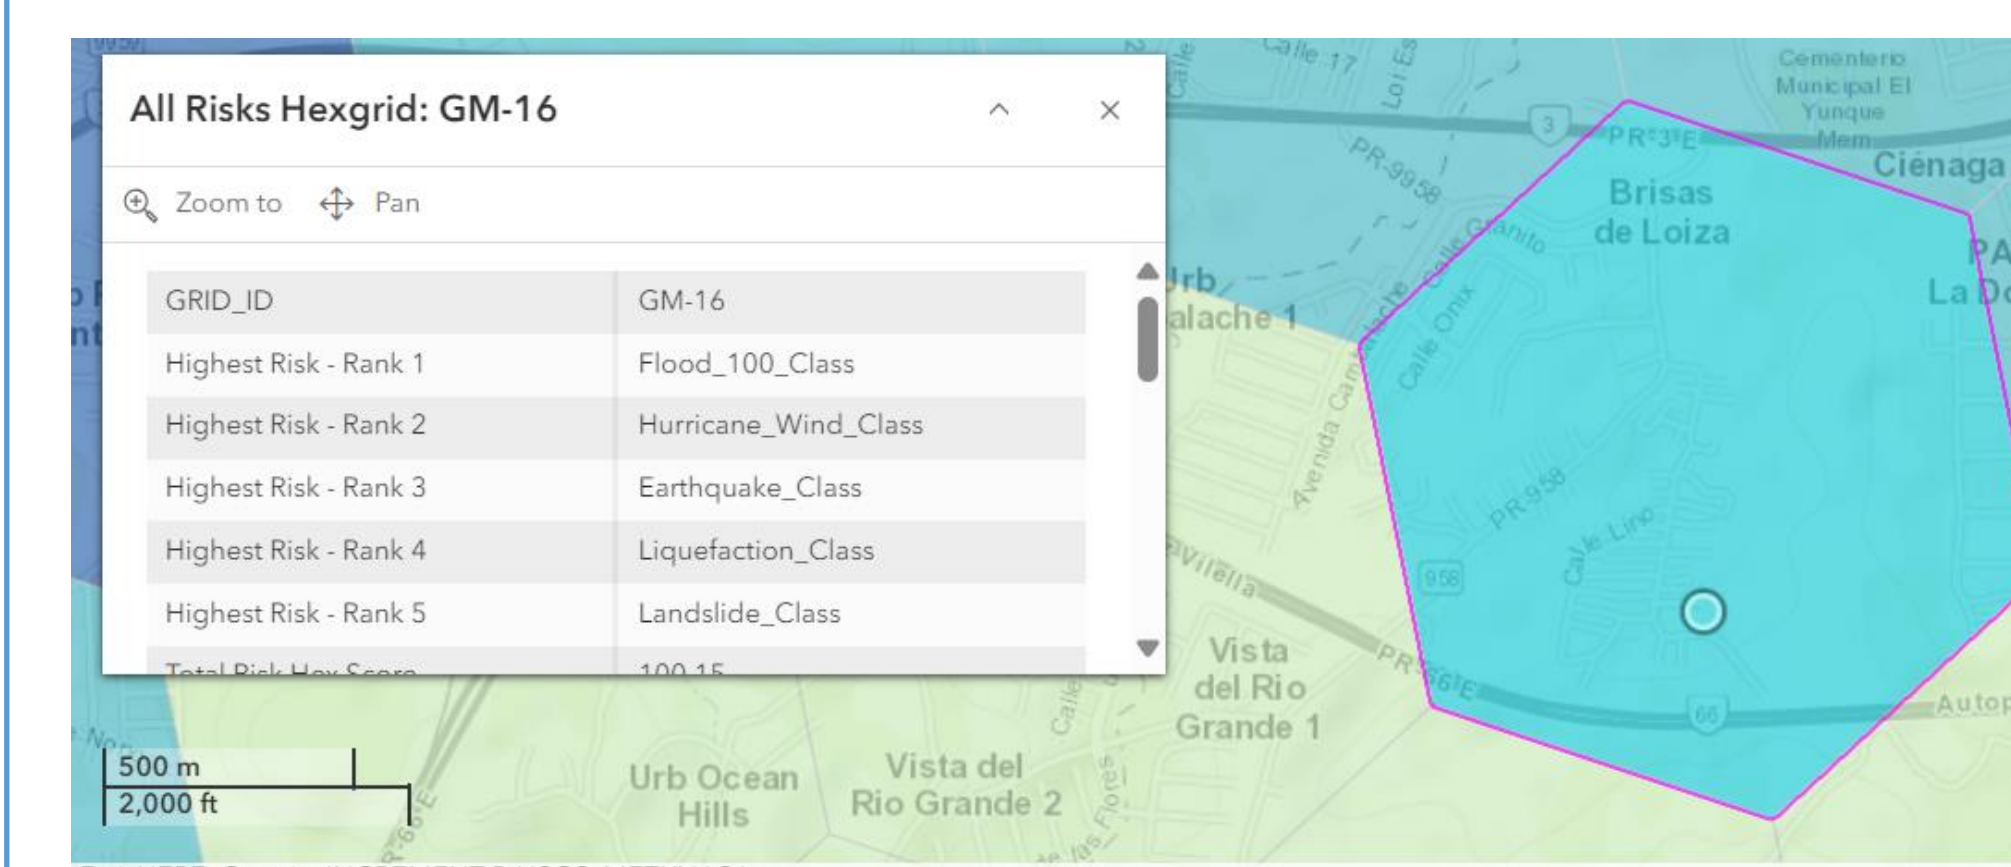
Figure 3. Potential risks at site, as per the Puerto Rico Risks and Hazards Dashboard

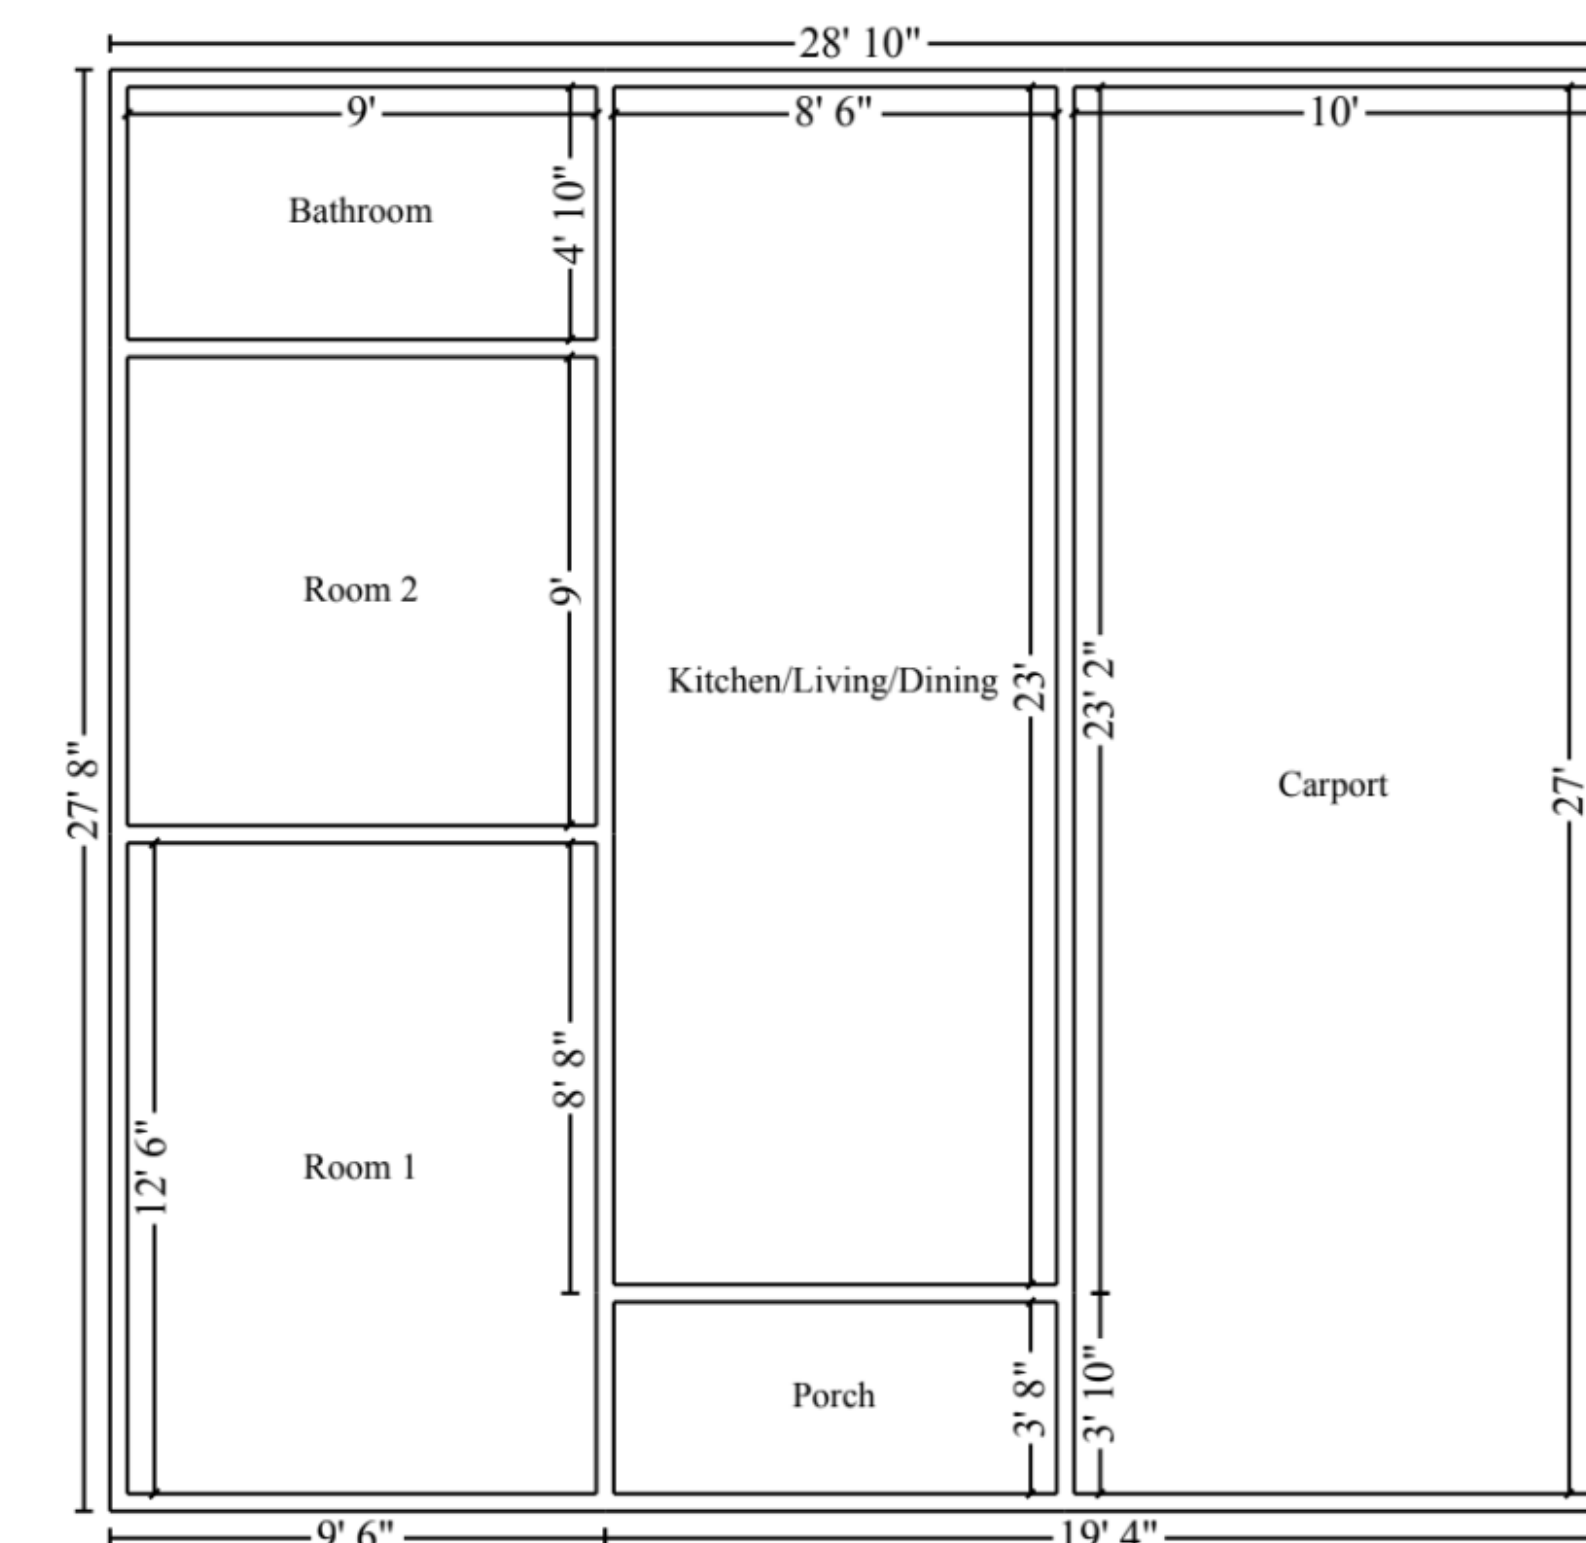
Storm damage identified at the property was documented and a detailed cost estimate was developed in Xactimate format, with an Applicant Final Lien amount of \$150,054.34 at closeout. A sketch of the property was developed in Xactimate, as seen in Figure 4. Storm damage identified at the property was documented and a detailed cost estimate was developed in Xactimate format, with an Applicant Final Lien amount of \$150,054.34 at closeout. A sketch of the property was developed in Xactimate, as seen in Figure 4. For the Lead-Based Paint survey methodology, it was unobtrusive in that surfaces were not damaged by the testing. All painted or coated surfaces at the property were tested with an X-Ray Fluorescence (XRF) analyzer. The survey did not include destructive, intrusive and/or exploratory testing. Hazard of lead in paint has been defined by HUD as any paint, varnish, shellac, or other coating that contains lead equal to or greater than 1.0 mg/cm² as measured by XRF or laboratory analysis, or 0.5 percent by weight (5000 mg/g, 5000 ppm, or 5000 mg/kg) as measured by laboratory analysis [Atomic Absorption Spectroscopy (AAS) or Inductive Coupled Plasma (ICP)]. Results can be interpreted as negative if the lead concentration measured by the XRF Spectrum Analyzer is less than 1.0 mg/cm². On the contrary, if the lead concentration measured by the XRF Spectrum Analyzer is equal or greater than 1.0 mg/cm², results are considered positive. For the Asbestos-Containing Material (ACM) survey, ACM is a material with greater than one percent (>1%) asbestos by Polarized Light Microscopy (PLM). Materials with detectable but less than one percent (<1%) are considered "trace ACM". Assumed ACM are those materials that are suspected to contain asbestos, but have not been sampled to verify, and are therefore assumed to contain asbestos unless testing proves the contrary. Materials containing asbestos are evaluated on their inherent ability to easily release asbestos fibers, which is called "friability". A material that is considered friable is a material that, when dry, can be crumbled, pulverized, or otherwise reduced to powder by hand pressure after an inspector has collected a bulk sample of the material and holds it in the palm of their hand. A material that is non-friable is a material that cannot be crumbled, pulverized, or reduced to powder by hand pressure.

Figure 4. Sketch of assessed property, including actual measurements and descriptions of rooms

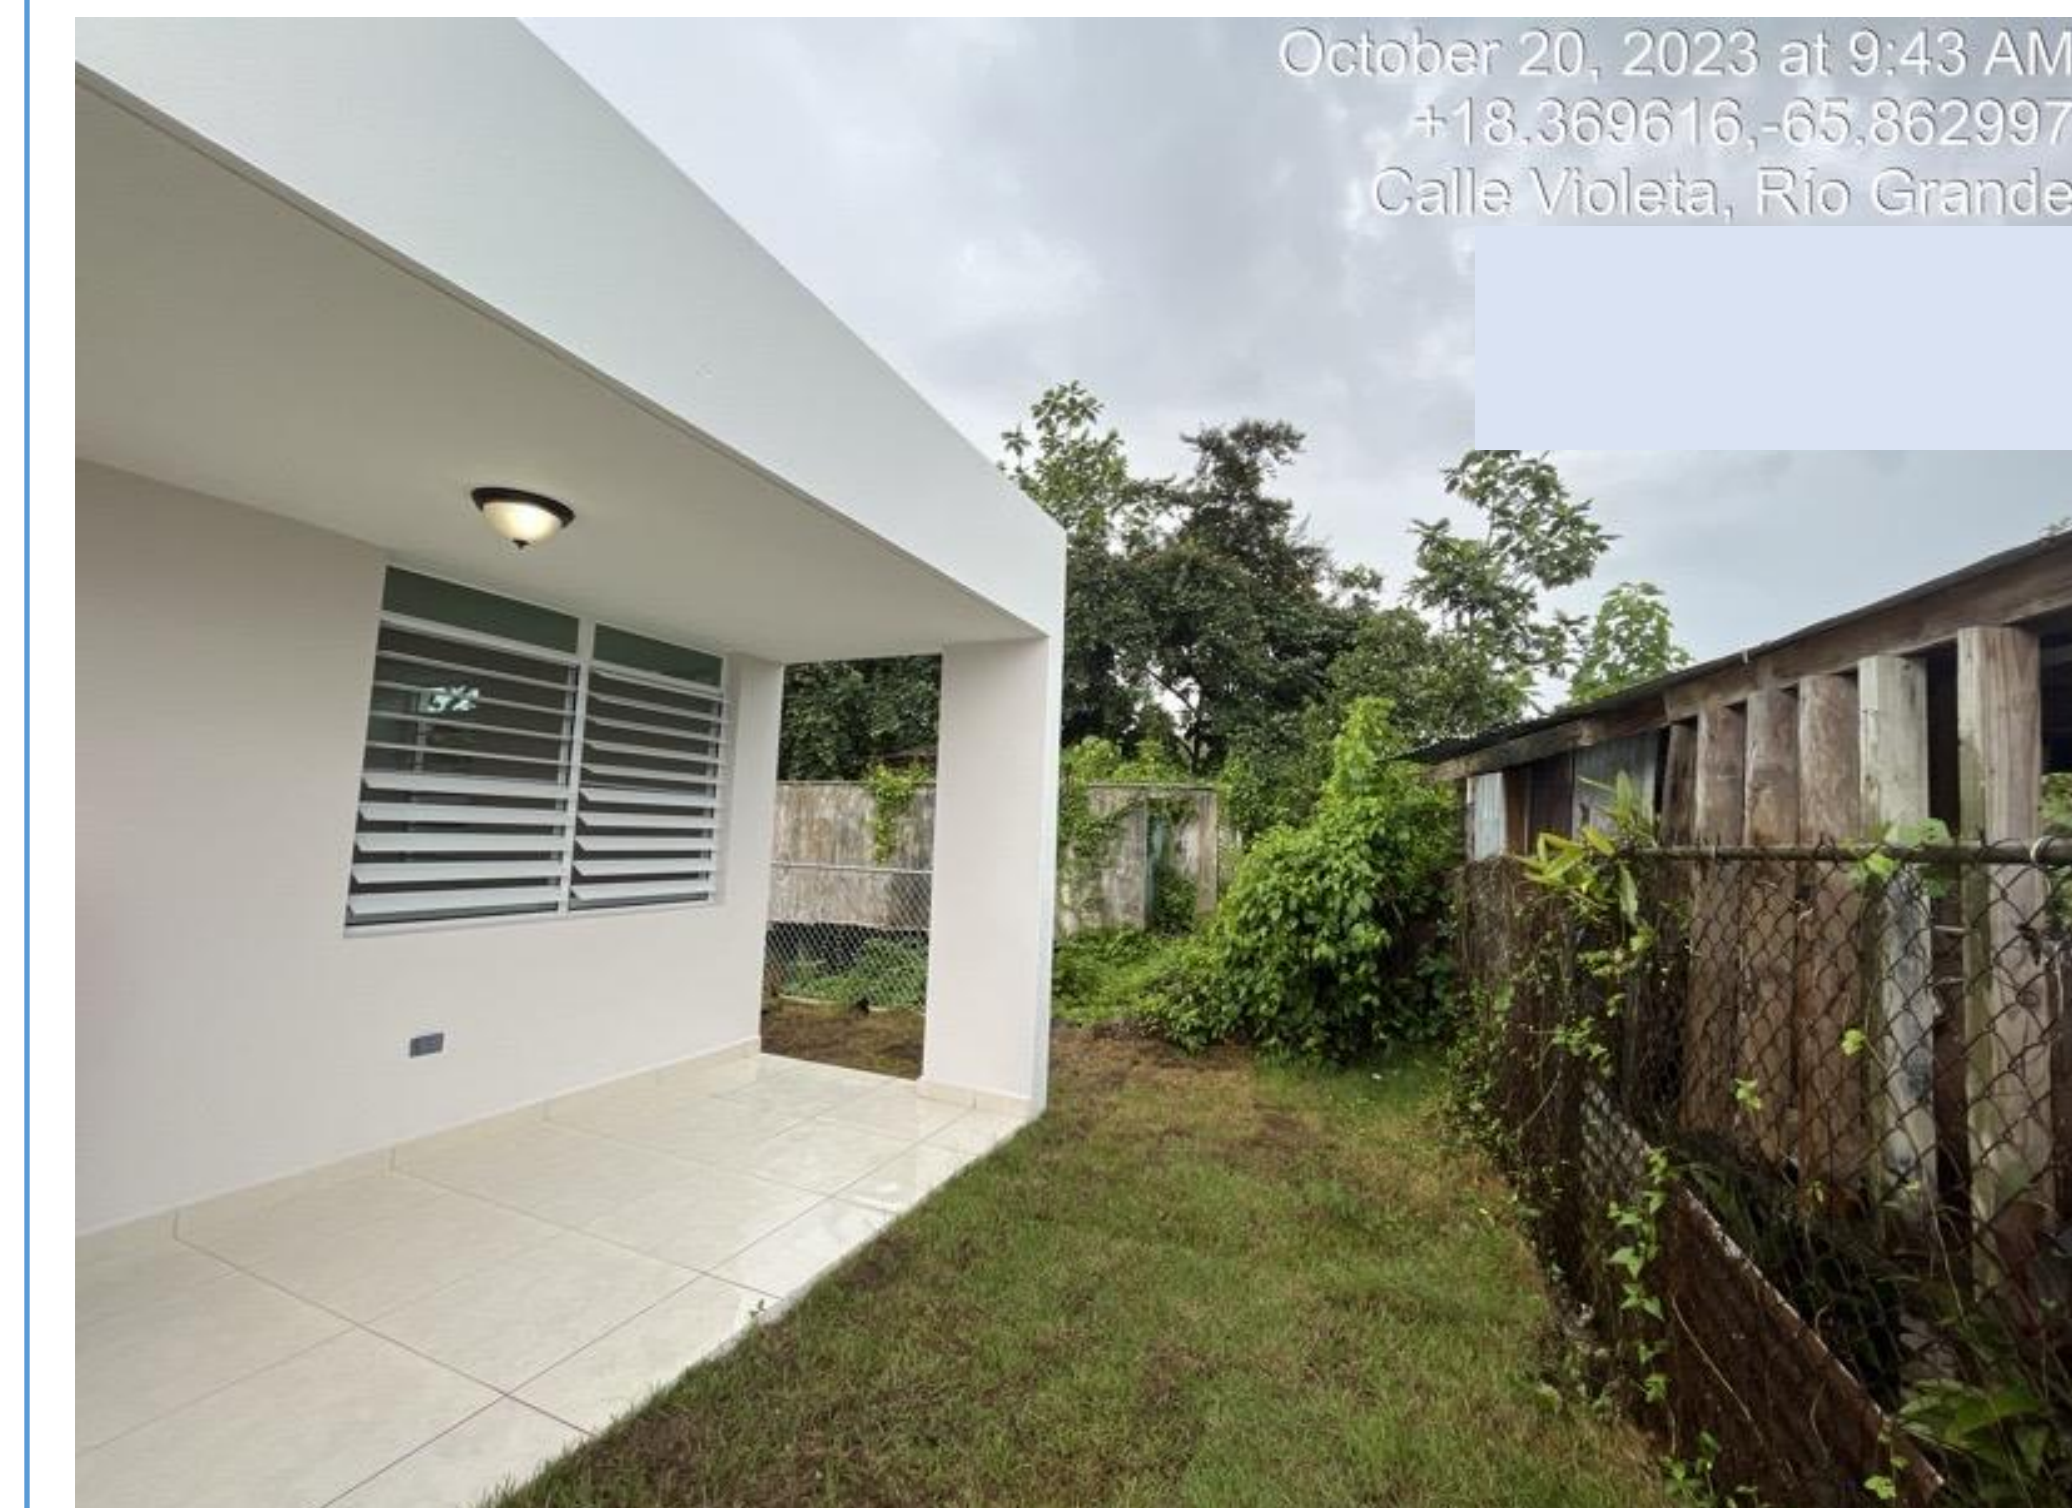
Figure 5. One-story 2-bedroom model home unit constructed at the original assessed site
