Author: Emmanuel Román Ramos
 Advisor: Christian Villalta Calderón, Ph.D.
 Master of Engineering in Civil Engineering
 Polytechnic University of Puerto Rico

This study analyses the effects of coastal erosion in the city of Loíza, Puerto Rico and how does the Carraízo Dam located at Trujillo Alto, Puerto Rico contributes to the sediment imbalance along the Loíza coast. The study centers on evaluating the hydrological impacts of anthropogenic disruption to the natural fluvial sediment transport dynamics, with emphasis on the alterations to the alluvial system and hydro morphological processes of the Río Grande of Loíza, resulting from the construction of the Carraízo Dam. Despite extensive research on mitigating coastal erosion, few studies have directly attributed shoreline degradation to dam construction. By analyzing the physical changes of the river using high-resolution bathymetric data and satellite imagery interpretation we can get preliminary results suggesting a correlation between coastal erosion and sediment imbalance cause by the Carraízo Dam high efficiency sediment retention. The reduction in sediment discharge not only exposed the riverbed material downstream but also

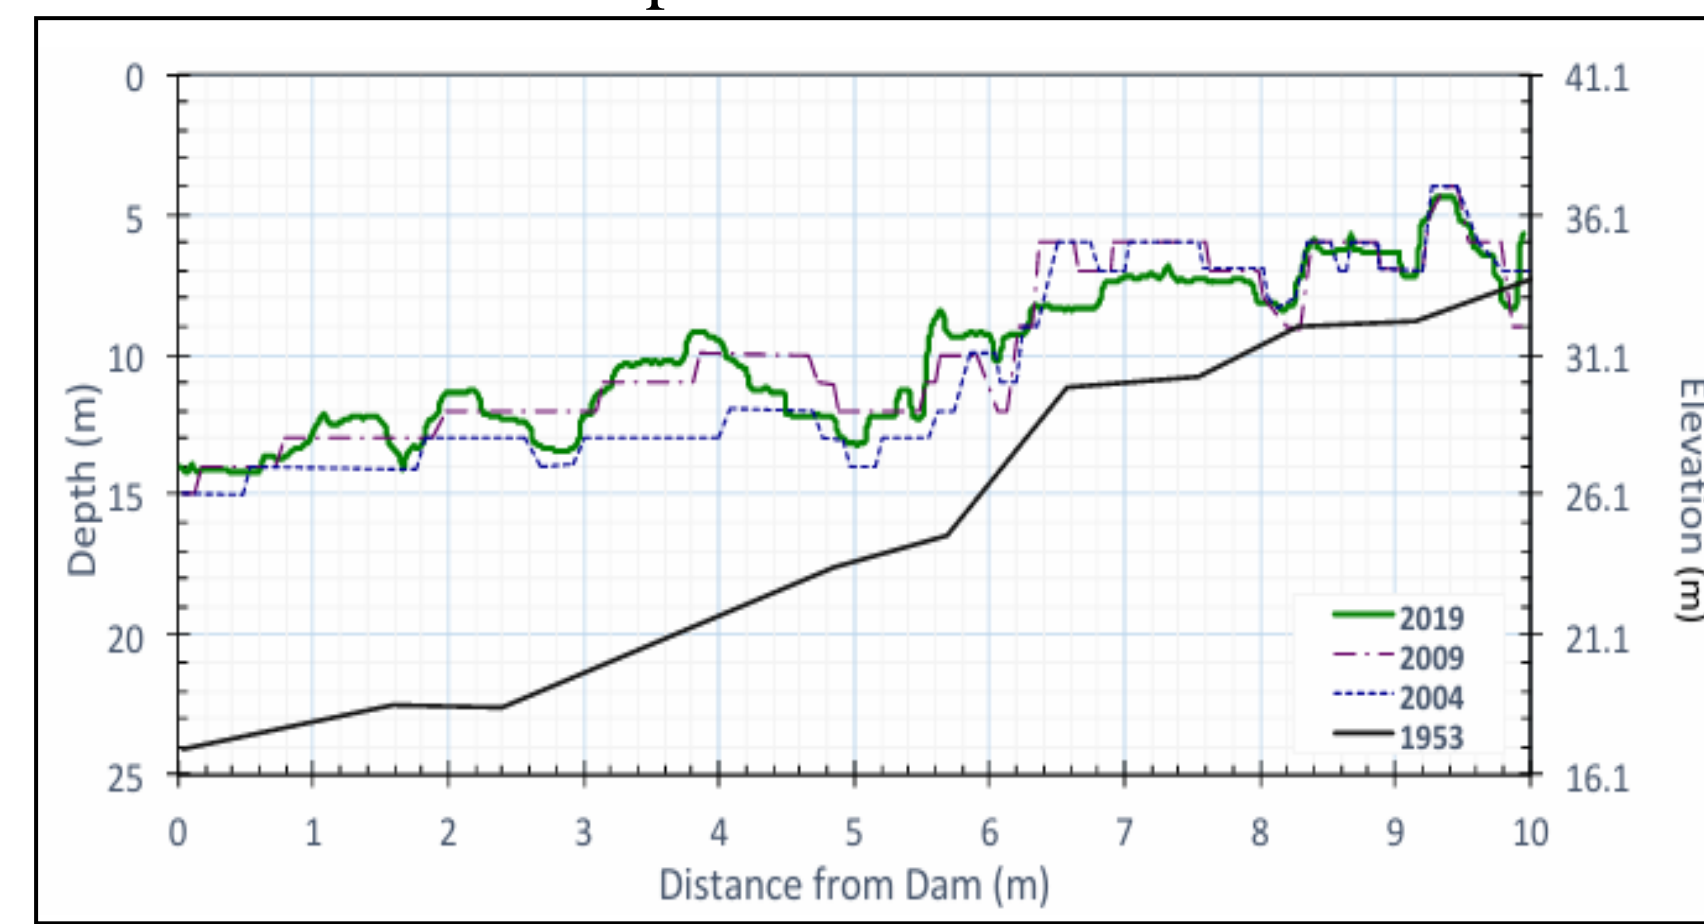
Bathymetrical Data: The bathymetrical report illustrated on the cross section of the Loíza River demonstrates that the Carraízo dam reduced its capacity by 11.75 million m³ in 2019. As of December 31, 2022 Ferdinan Quiñones reported a decrease by 13.67 million m³ which represents 51 percent of the total capacity. A research study involving the Elwha and Glines Canyon dams on the Elwha River revealed the presence of 11.1 million m³ of sediment. The sediments that were trapped on the reservoir were the cause of the measurable changes in morphology and rates of change in the fluvial and coastal landforms. In 2011, the removal of dams on the Elwha River was the largest project of its kind at that time, resulting in the greatest sediment release from a dam removal.
