Roberto Rivera De Jesús, PE  
 Advisor: Héctor J. Cruzado, PhD, PE  
 Polytechnic University of Puerto Rico

This project documents the comprehensive refurbishment of a cooling tower at Amgen's biopharmaceutical facility in Juncos, Puerto Rico. The tower exceeded its service life with significant degradation affecting structural integrity, mechanical systems, and heat transfer performance. Executed September 15-October 9, 2025, the refurbishment was completed one day ahead of schedule. Performance testing demonstrated 15% energy reduction and improved cooling capacity. The refurbishment extends service life by 15-20 years at a lower cost than a full replacement.

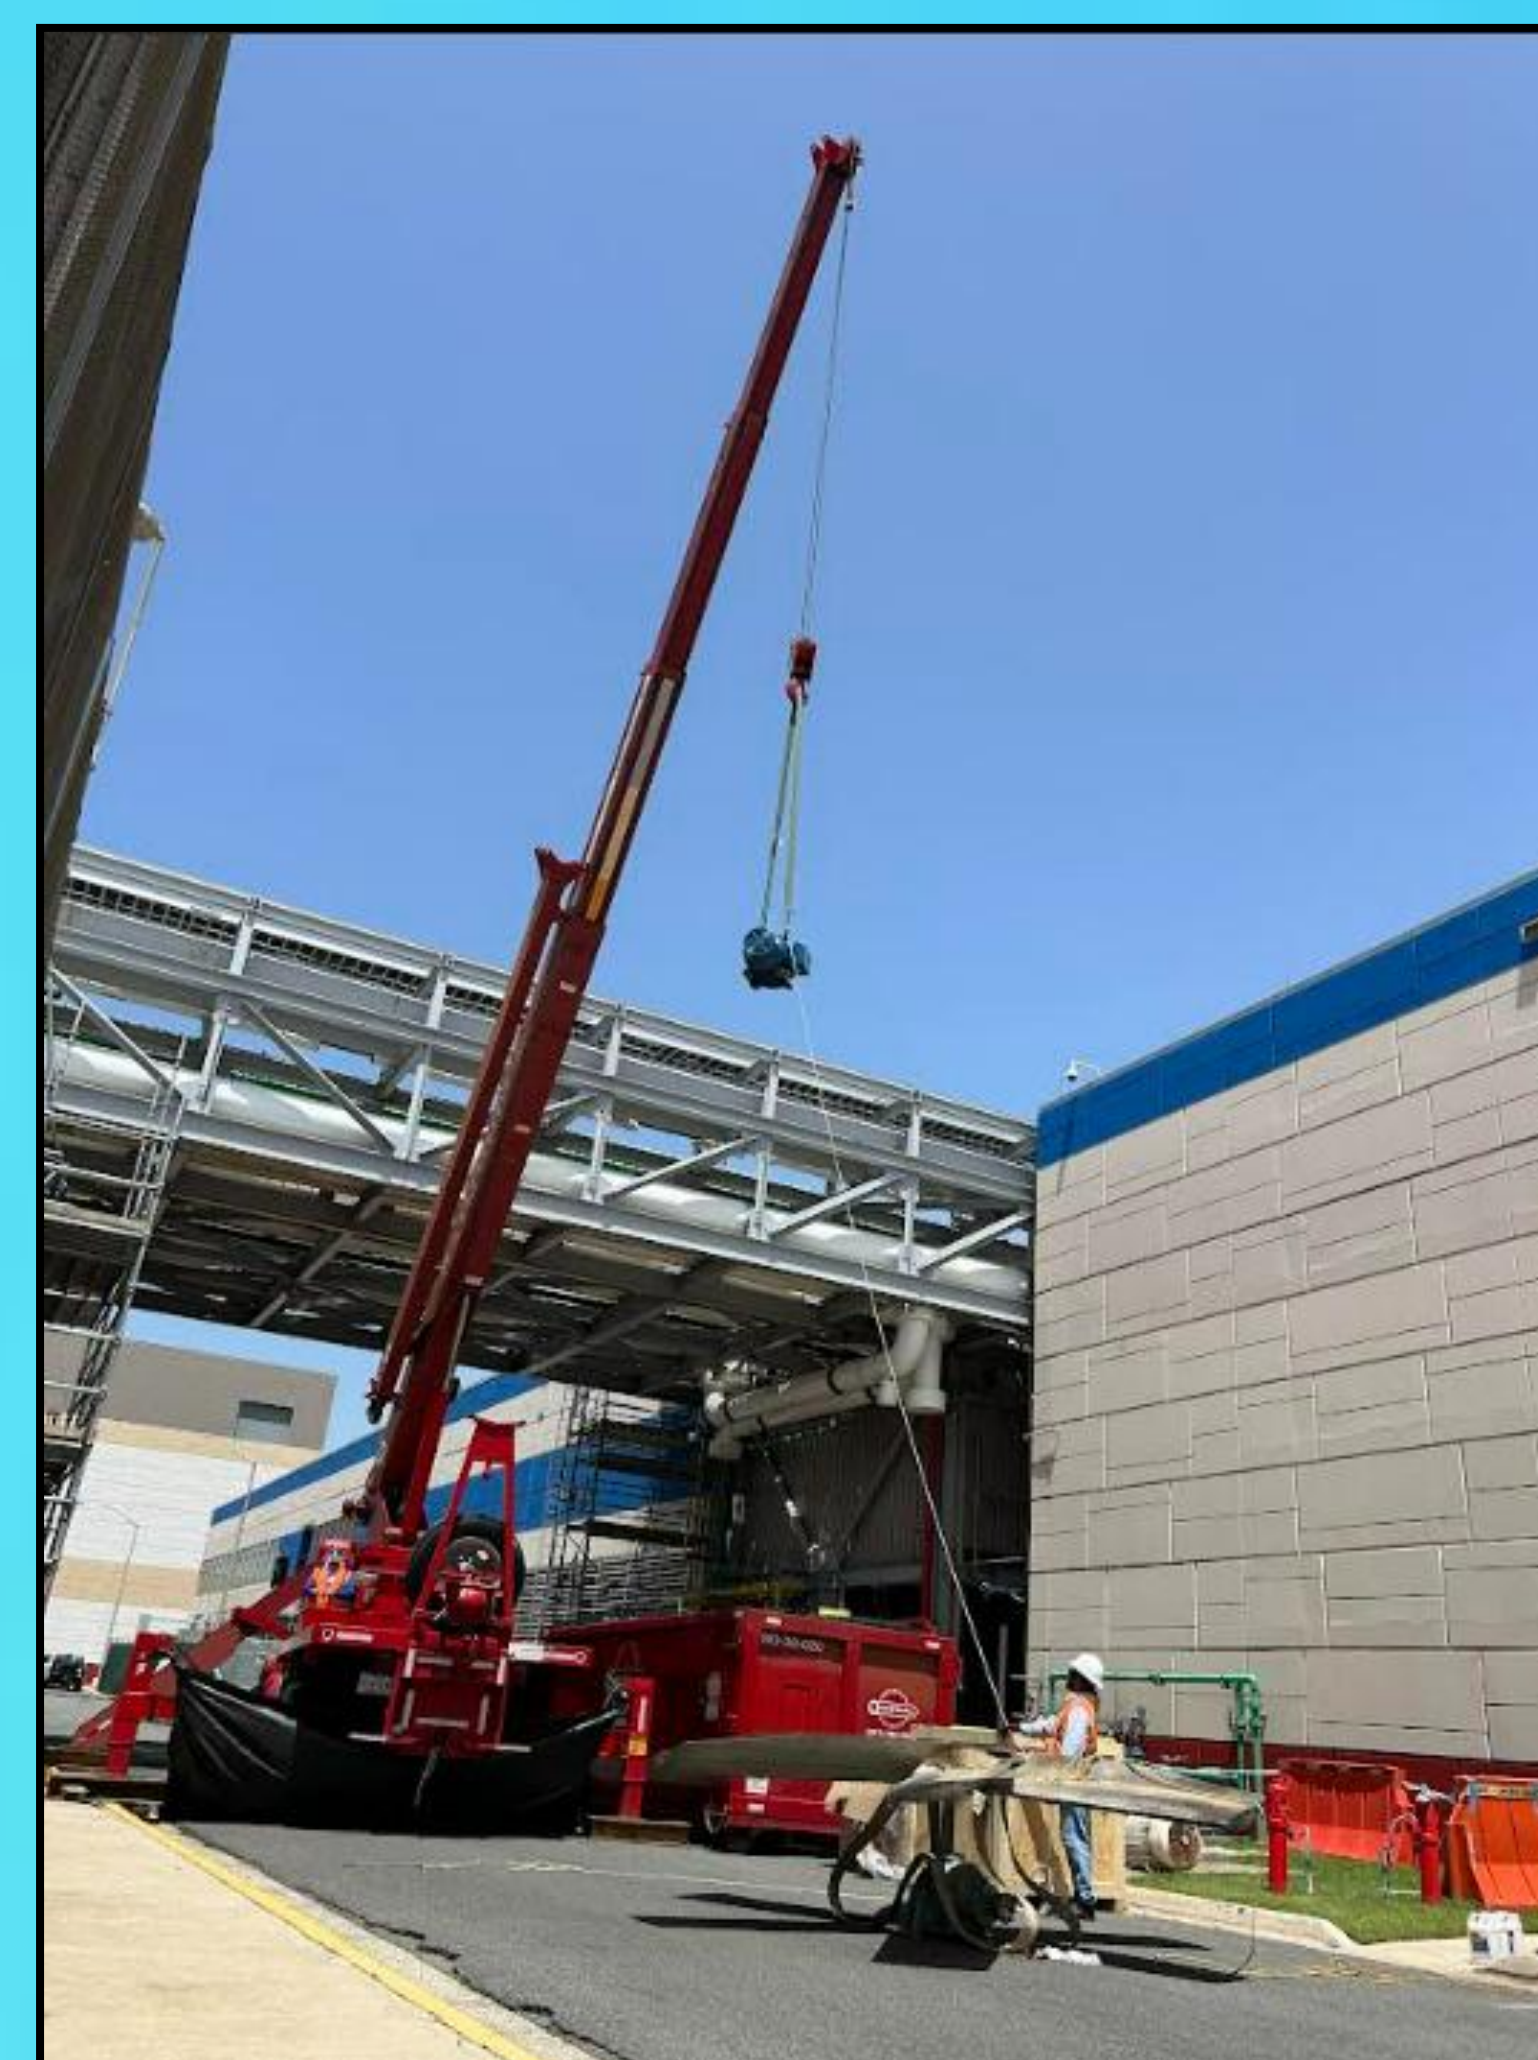
Figure 2: New motor installation with new transmission pending installation

The mechanical upgrade involved installing a new premium-efficiency motor which was laser aligned to the gearbox assembly. The transmission system was completely replaced including gearbox, drive shaft, and fan mounting. Vibration sensors were integrated for condition monitoring. Fill media installation involved positioning modular sections with proper spacing for uniform water and air distribution. Refurbishment activities are presented in Figure 2 and Figure 3.

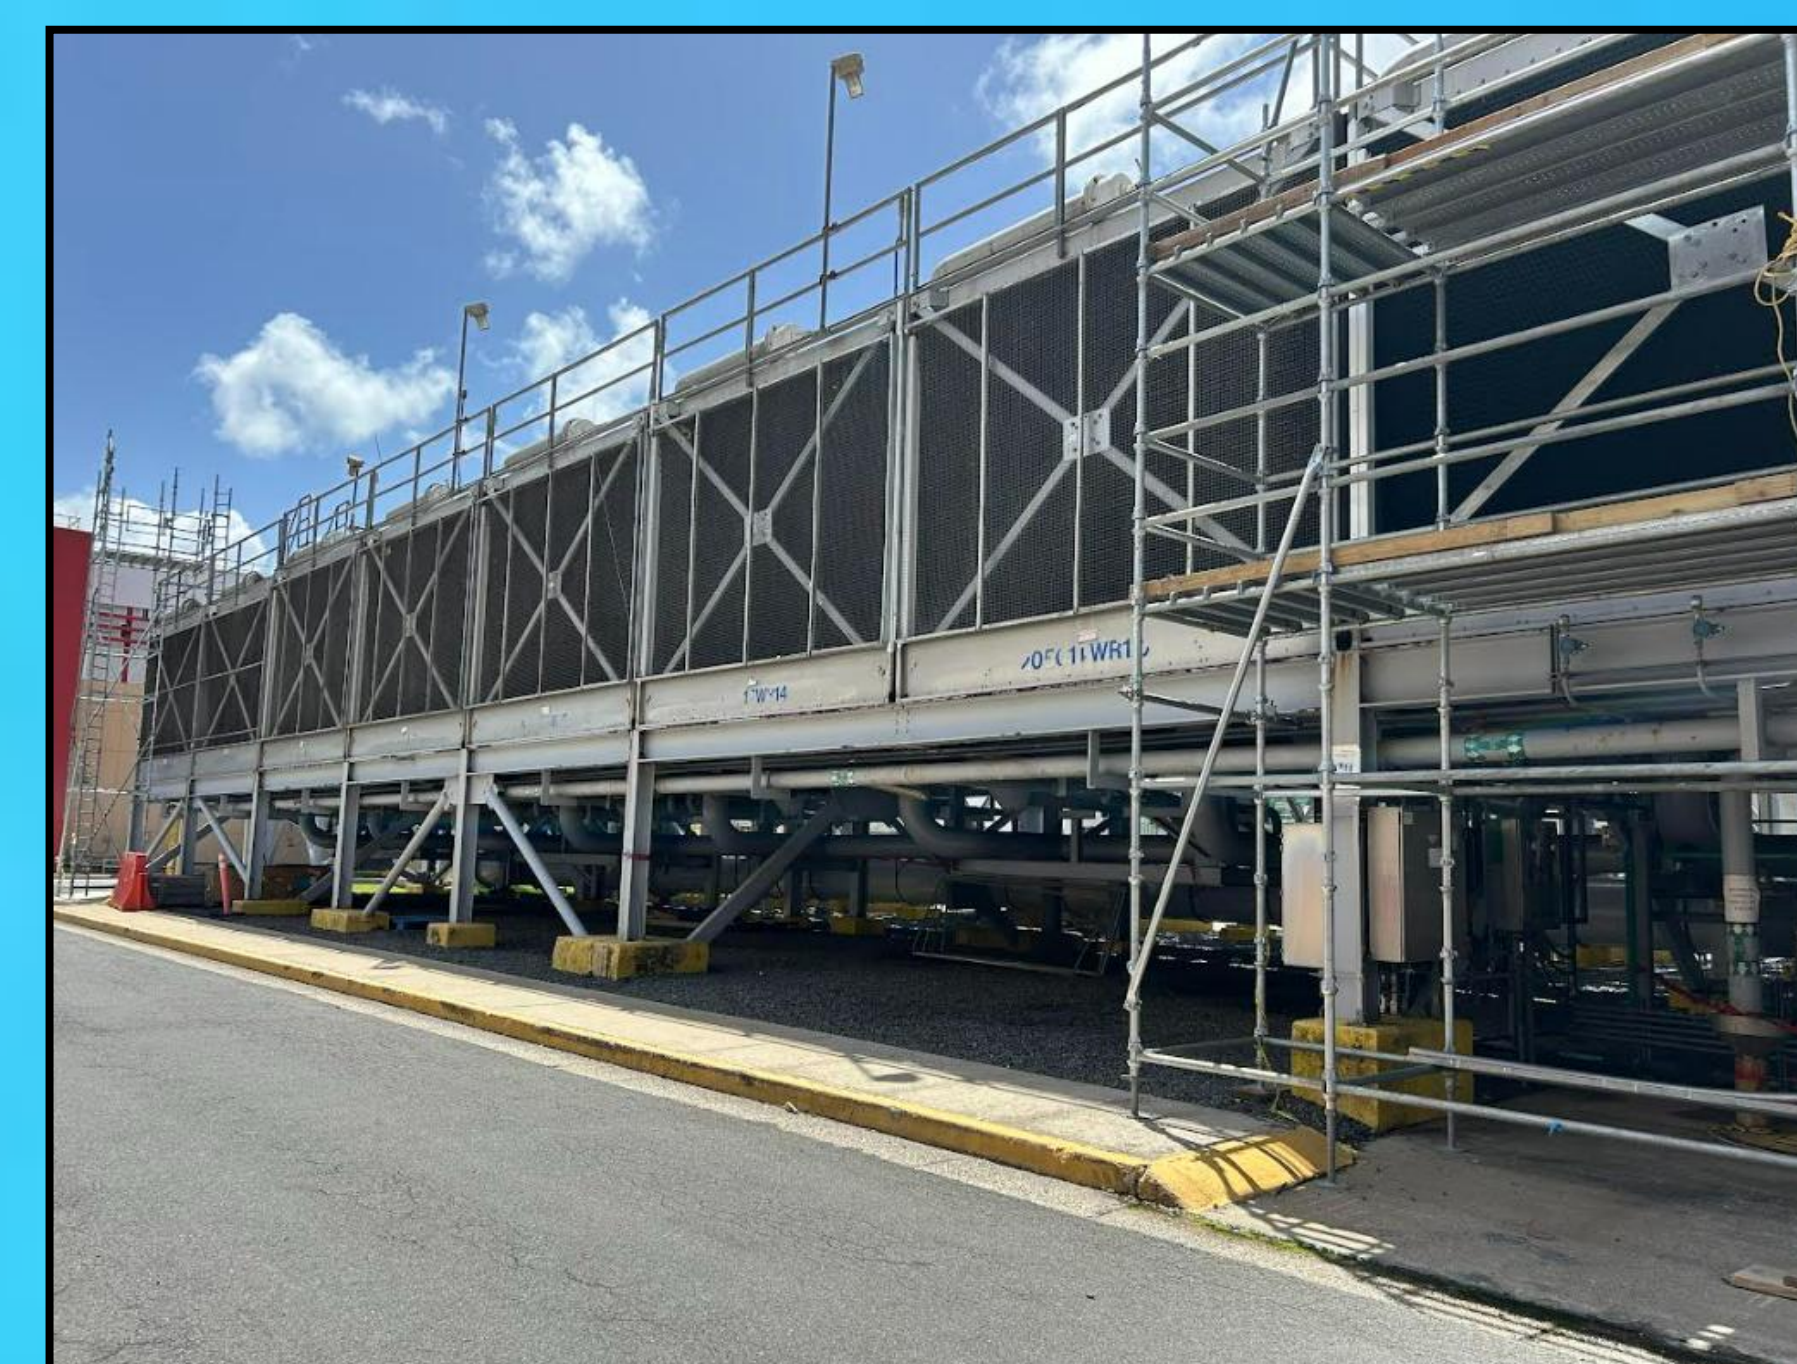
Figure 3: Central utility plant cooling towers with scaffolding installed for refurbishment.
