Abstract

Tray seal variability in sterile medical device packaging can affect package consistency and reduce the effectiveness of inspection controls. This project evaluated abnormal seal width and Tyvek marking observed in thermoformed trays at a medical device manufacturing facility. A DMAIC-based approach was used, including record review, process mapping, dimensional assessment, and cause-and-effect analysis. The investigation identified three main contributors: supplier-generated flange variation during tray trimming, equipment setup associated with abnormal Tyvek marks, and unclear inspection criteria for seal width and mark interpretation. Supplier investigation found flange widths as low as 0.25 in., below the minimum acceptable width of 0.28 in. Corrective actions included revision of design and inspection requirements, supplier die-cutting improvements, and implementation of a Go/No-Go inspection. These actions strengthen packaging controls and support reliability.

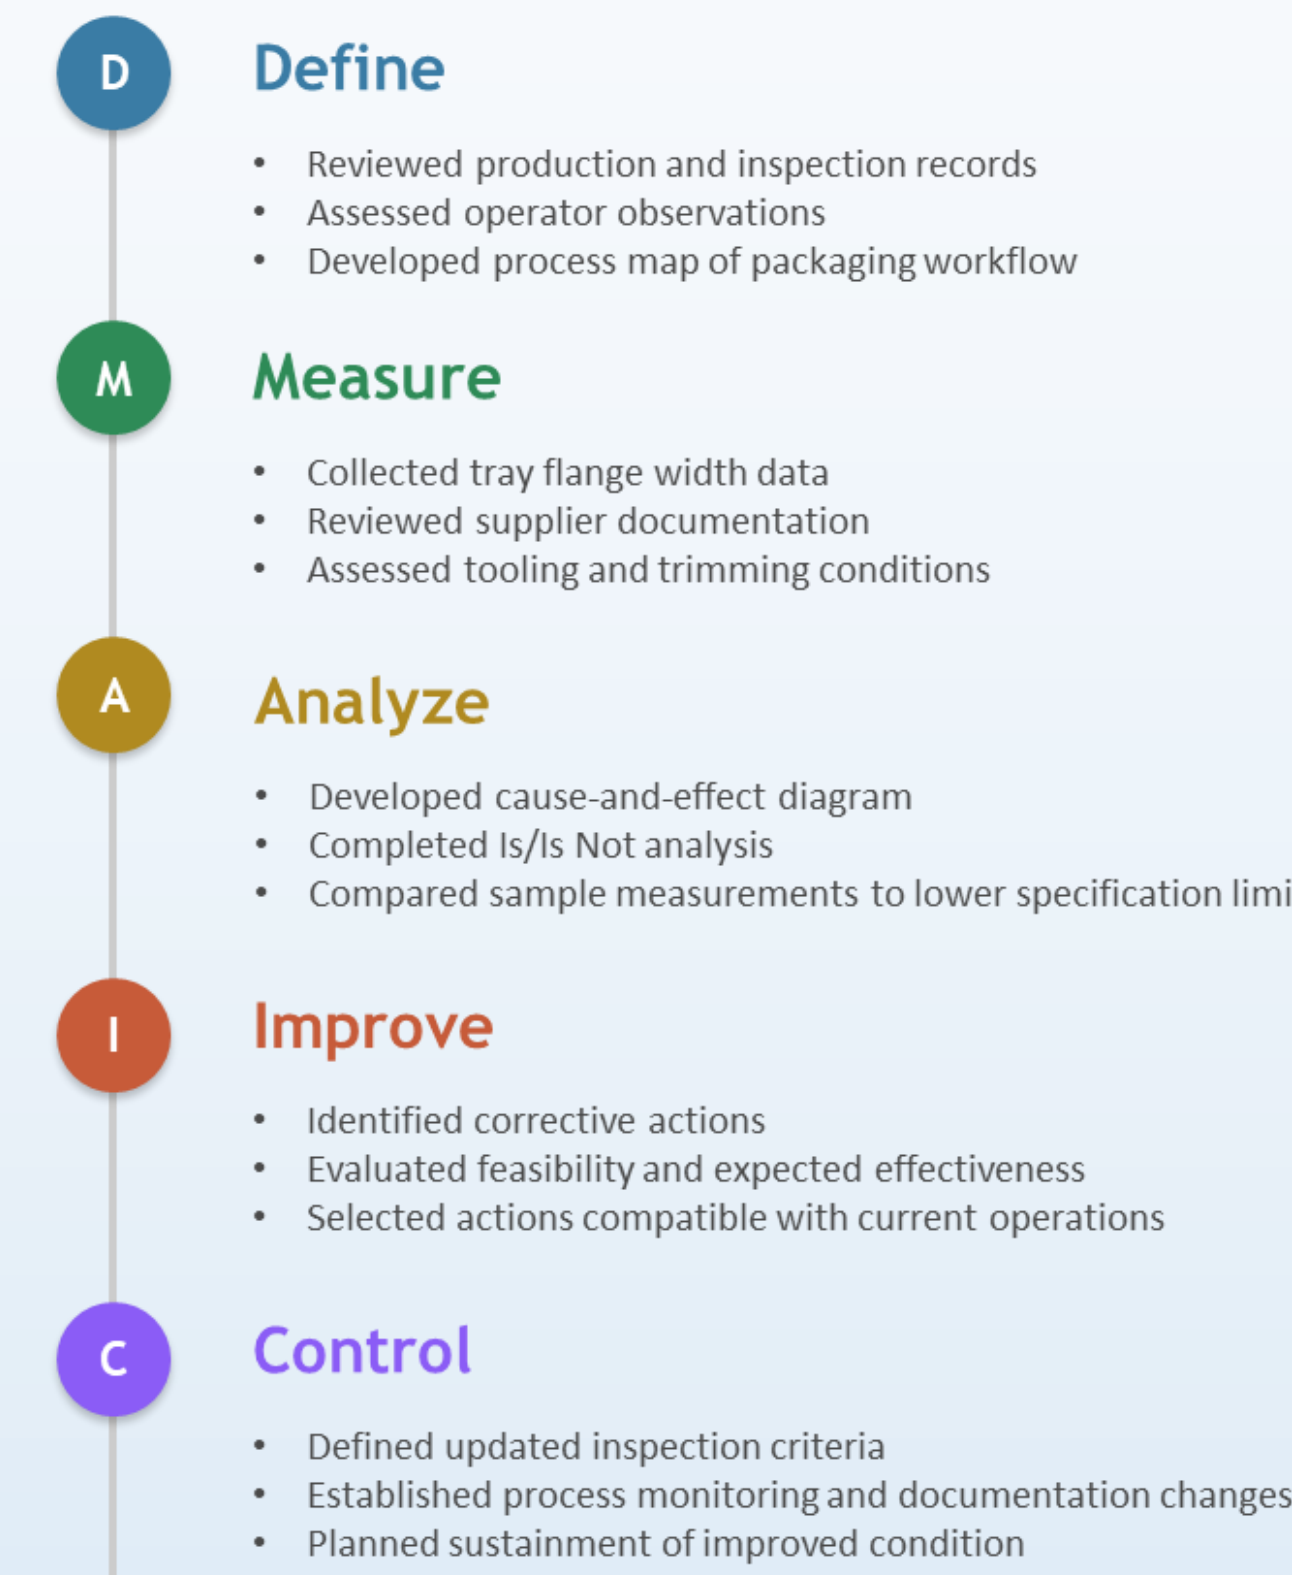
A DMAIC-based approach was used to investigate tray seal variability and guide the project from problem definition through corrective action planning and sustainment.

In the **Define** phase, production records, inspection data, operator observations, and a process map were used to establish the scope of the issue and identify where it was detected in the packaging workflow. In the **Measure** phase, tray flange width data, supplier documentation, and tooling conditions were reviewed to characterize dimensional variation. In the **Analyze** phase, an Is/Is Not analysis, a review of sample flange-width measurements against the lower specification limit, and a cause-and-effect diagram were used to identify the main contributors to tray seal variability. This tool helped structure the investigation and narrow the most significant contributors to the observed defect. Root cause analysis identified three principal contributors: supplier flange variation, equipment setup, and inspection criteria.

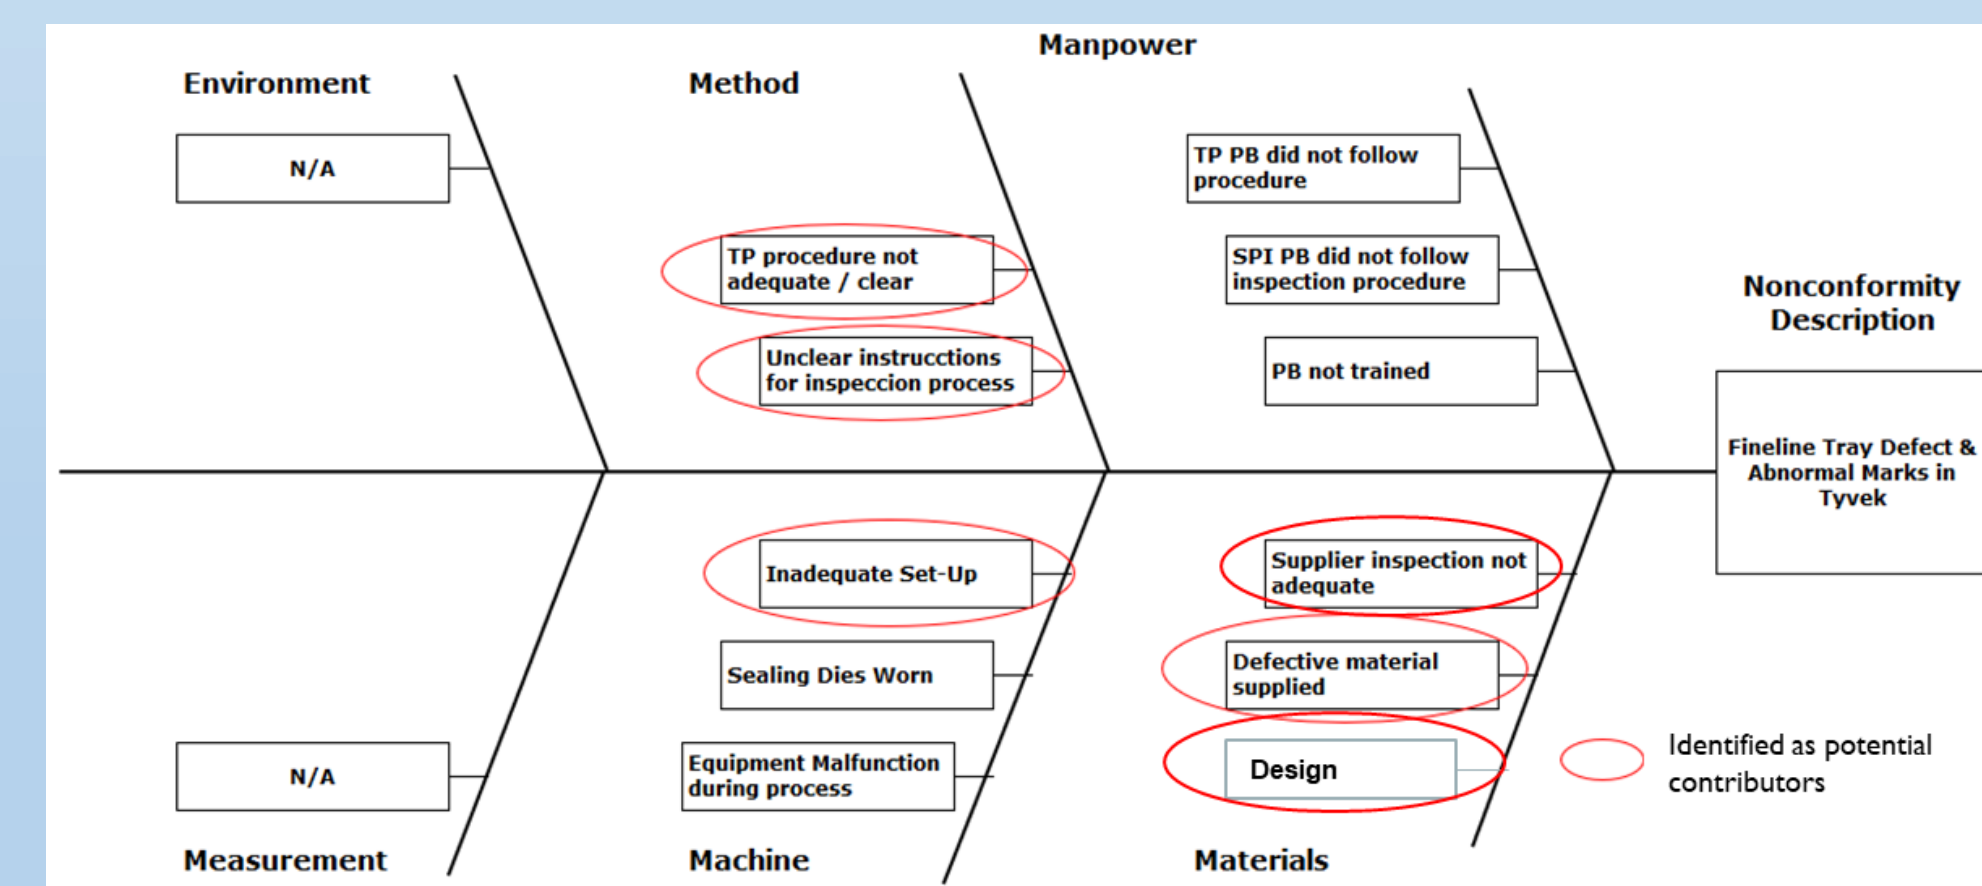
Figure 1
Cause-and-effect diagram

The investigation showed that the observed defect was not caused by a single factor, but by the interaction of material variation, equipment setup, and unclear inspection criteria. Review of training and device history records confirmed that product builders were trained and that no prior nonconformances related to uneven tray sides or abnormal Tyvek marks had been documented. Interviews and work instruction review indicated that the available visual aids and inspection criteria did not clearly define unacceptable abnormal marks or minimum seal width requirements, which increased the likelihood of inconsistent inspection decisions. Equipment assessment of the Belco blister sealer identified a misalignment between the sealing die and the hot plate recess area, contributing to abnormal Tyvek marks. At the material and design levels, the tray flange requirement was confirmed as 0.40 ± 0.03 in.; applying the 75% seal width requirement to the minimum flange width of 0.37 in. established a minimum acceptable seal width of 0.28 in. Supplier investigation found flange widths as low as 0.25 in., confirming that nonconforming trays could be produced and accepted. Overall, the most significant contributors were grouped into three principal areas: supplier-induced flange variation, inadequate equipment setup, and insufficient inspection criteria.

- Product builders were trained; no prior related NCs documented
- Sealer die misalignment contributed to Tyvek marks
- Minimum acceptable seal width = **0.28 in.**
- Supplier flange widths observed as low as **0.25 in.**
- Main contributors: **material variation, equipment setup, inspection criteria**
