Abstract

The Scrubber system SC-25 A/B is an emission control system that supports a manufacturing process of oral solid dosage in a pharmaceutical plant located in Barceloneta, Puerto Rico. Although the scrubber in subject is not an actual manufacturing system, it is responsible of removing 99% of volatile organic compound from the air exhausted from manufacturing process. While scrubber operations are highly regulated by the Environmental Protection Agency, several concerns were raised in the pharmaceutical plant due to consistent operational failures due to low flow rate alarms. Performing voice of the customer analysis, data gathering and field visit, the issue was assessed and addressed to provide a solution of improvement. Low flow rates in the scrubber are triggered by the following drivers: effluent water quality, pipe size capacity, and strainer capacity. As a result, short- and long-term improvement proposals were presented to the system owner which includes Preventive Maintenance Revision, Piping and Strainer resizing increase and propose the implementation of local water treatment using biocide for the scrubber.

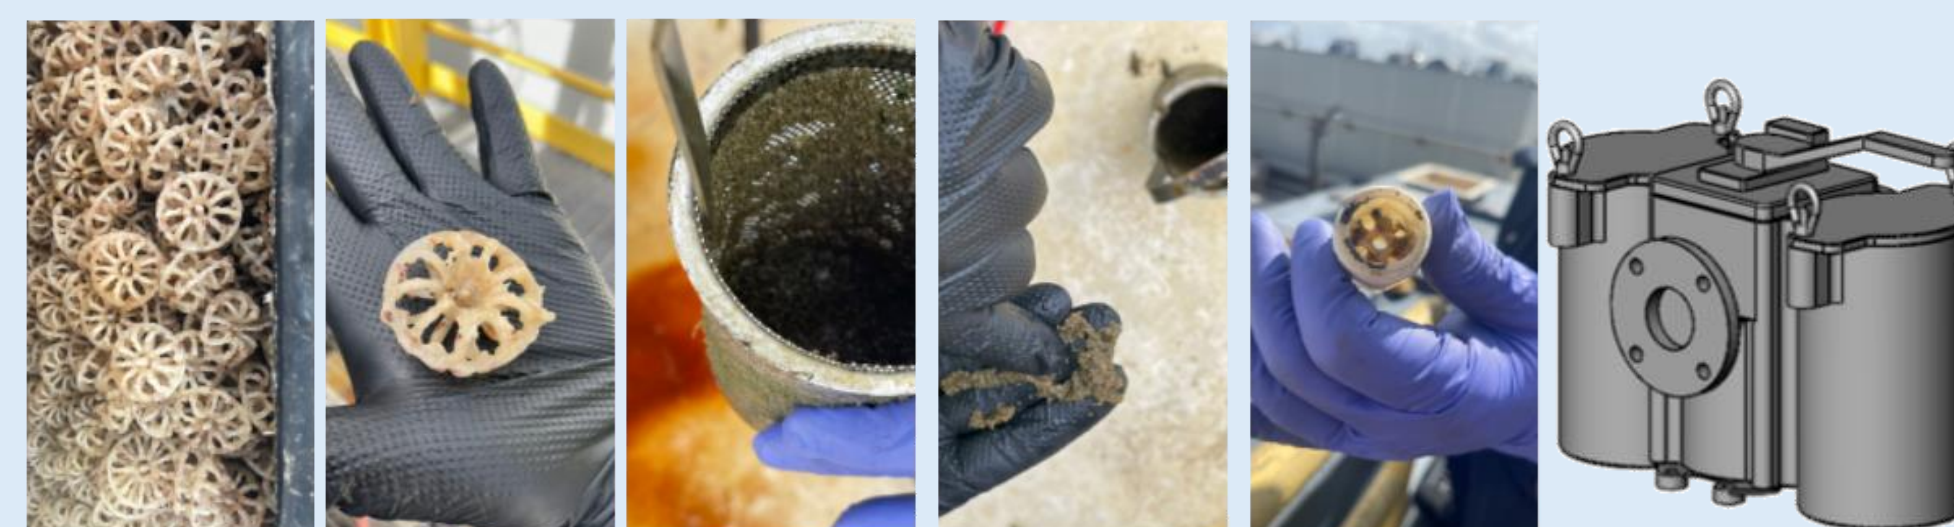
Figure 3
Solid Sludge and organisms trapped in packing and strainers

The Scrubber SC-25 A/B, is fed by a supply of effluent water provided by the Wastewater Treatment Plant. The water supplied may contain particulates from wastewater process including bacteria organisms along with other solid particulates that is then transferred through the effluent supply into the Scrubber SC-25 (A/B). The effluent water forms a solid sludge that is injected into the scrubber causing the scrubber system being prone constant clogs. To control clogs in the pipeline, pump, and nozzles, strainers are installed into the water pipeline to collect the solidification components from the effluent water. [4]

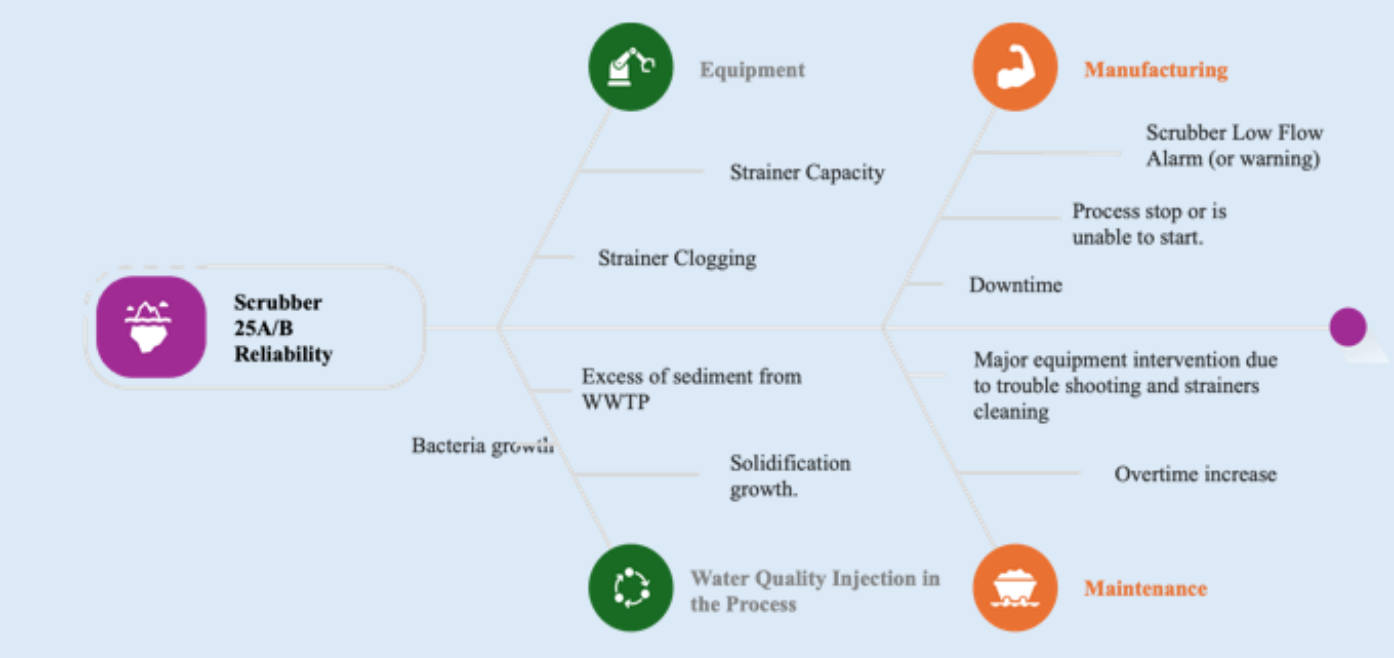
Figure 5
Fishbone Analysis to Evaluate Scrubber SC-25 A/B Issues Rule Out

The fishbone analysis tool was used to organize and sort the data in terms of cause and effect. Figure 3 shows the fishbone analysis performed to understand the issues related to the scrubbers from the different cross functional areas that are impacted by the consistent required troubleshooting. Using this tool, the issues to address were defined in the aim to address the reliability improvement. Based on this information, short- and long-term enhancements proposals were designed to help the scrubber A/B system improve reliability operations.
