Abstract

The Johnson & Johnson Vision plant in Añasco manufactures Non-Toric intraocular lenses (IOLs), which have recently experienced a recurring issue of unintended fiducial markings. These defects, if undetected, compromise product integrity, patient safety, and production efficiency. Root cause analysis determined human errors specifically incorrect machine programming selection as the primary contributor. To address this, an upgraded version of CNC Program Assembler software was developed to enforce correct program usage through barcode scanning, preventing operational oversights. Complementary procedural actions included operator training, standard operating procedure updates, and engineering test validations. A cost benefit analysis revealed substantial material and labor losses due to incorrect production, justifying the proposed corrective measures. The revised system enhances traceability, reduces waste, and ensures consistent quality. Ongoing monitoring and feedback collection are planned to ensure sustainable improvements and compliance. This initiative reflects a strategic integration of risk management, process optimization, and quality assurance to support continuo

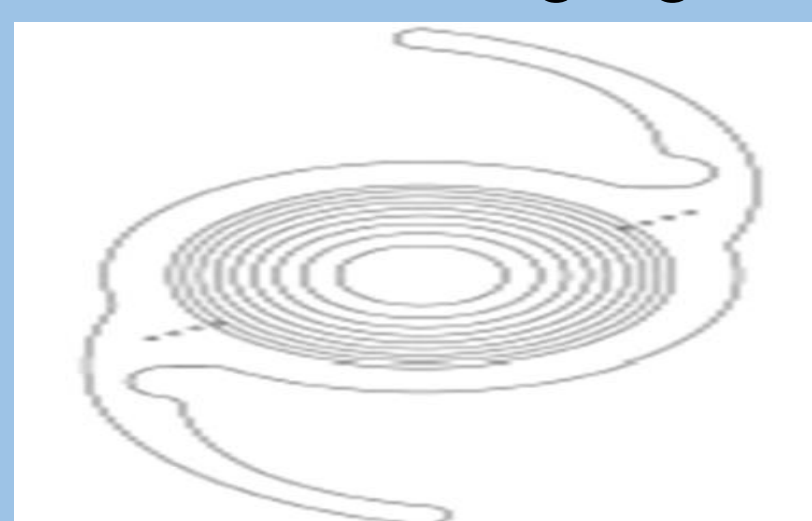
Figure 1: Toric Lens

Operator interviews and SOP reviews revealed inconsistencies in program selection. Operators occasionally failed to switch from Program 091 to Program 051 when transitioning from Toric to Non-Toric orders, causing the machine to execute the last loaded program and apply unintended fiducial markings to Non-Toric lenses.

Root cause analysis confirmed that the defect stemmed from human error rather than equipment malfunction or software bugs. The failure to switch programs was attributed to oversight and lack of an automated verification system. Although post-milling inspections typically caught the defects, the resulting scrap and time loss were substantial.

To resolve the issue, both technical and procedural CAPAs were introduced. Technically, a prototype CNC Program Assembler version 1.4 was developed to replace version 1.3.
