Coastal Erosion as a Function of Sea Level Rise and Sediment Imbalance

Emmanuel Román Ramos
Master of Engineering in Civil Engineering
Advisor: Christian A. Villalta Calderón, Ph.D.
Polytechnic University of Puerto Rico
Graduate Project EXPO, May 2025

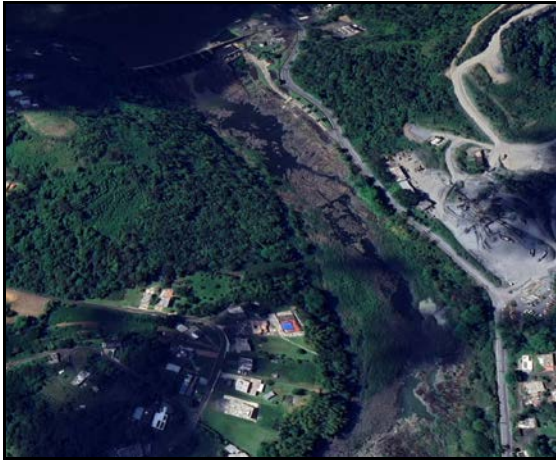
Figure 2
Exposed Riverbed Downstream Carraízo Dam

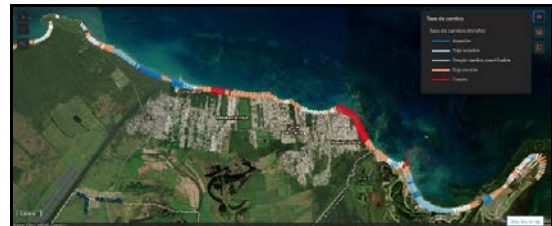
Figure 3
Rate of Change Río Grande of Loíza 1901 to 2018

floods, 2) the variability in shelf morphology, 3) the availability of sand deposits in the nearshore area, 4) beach location and orientation, 5) human activities and 6) the presence of submarine canyons. A study from Maritza Barreto-Orta suggests that the main sand loss in the North coast of Puerto Rico was from 1964 to 1987. This erosion could be related to the occurrence of high amplitude waves generated by extratropical and tropical cyclones systems, human activities such as construction of dams and sand extraction. Between 1961 and 1971, most beaches experienced the highest erosion rates due to high amplitude waves from the north and northwest, as recorded by WIS data. From 1971 to 1975 waves approached from the North and Northeast (0 – 65 degrees) reporting the presence of lower amplitude waves that caused the reduction in erosion rates in the North part of the island. The construction of breakwaters, docks, and water reservoirs could have caused a major reduction of sediment input to the beaches. The coastal structures appear to have produced new local current circulation on the nearshore that had generated sand transport toward offshore. The Loíza municipality has a shoreline change rate of erosion of -1.93 m/yr utilizing a data from 1970 to 2010 [4]. The coastline retreat can be observed on Figure 3.

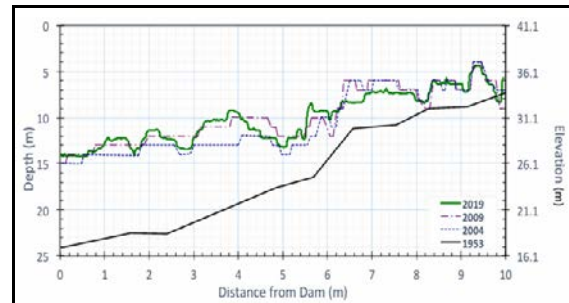
Figure 6
Bathymetric Profile of Lago Loíza for the Last Three Surveys and Compared to the 1953 Pre-impoundment Profile [7]

Based on the bathymetrical data, a cross-section of the Loíza Lake has been illustrated in Figure 6. The cross section presents bathymetrical report data from the years 2004, 2009, and 2019 for comparison.

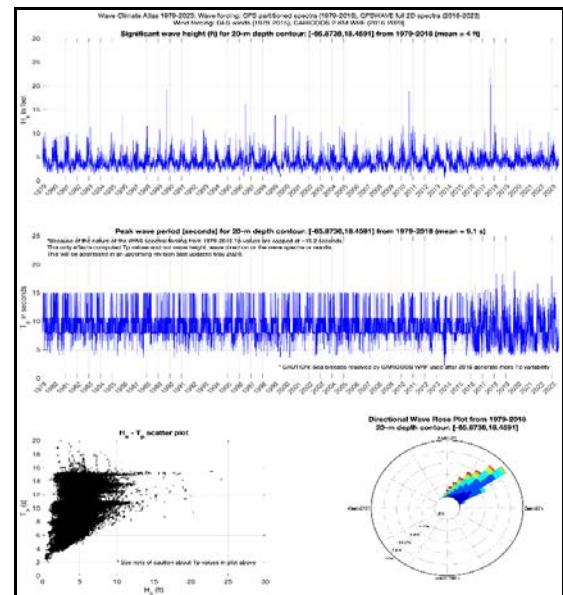
Figure 11
Depth Contour at 20 m for a 40-Year, Time Series Plot and 40-Year Wave Rose Plot

The Caribbean Coastal Ocean Observing System has data from 1979 to 2025. From a buoy with a 20 m depth contour the height of the waves, periods in seconds and wave direction can be determined.

The Atlantic Ocean wave pattern significantly influences coastal erosion in Loíza. Particularly when the waves originate from the northern or northwestern direction. Figure 11 shows the directional wave rose plot at a depth of 20 meters, indicating that 5.6 percent of the waves originate from the northwest with heights of up to 2.74 m. Although waves from the northwest are less frequent compared to those from the northeast, their impact on the coast is significantly greater. Waves from the northeast account for 27 percent of occurrences, with wave heights of 1.52 m or less. For the North coast, the highest short period waves were found from May to October and long period waves occurred from October to December. Strong wave action leads to the removal of beach sediments, causing the shoreline to retreat.
